LEVEL 1 REPLACEMENT RESERVE REPORT FY 2023 ANNAPOLIS COVE HOA

ANNAPOLIS COVE HOA

ANNAPOLIS, MARYLAND

February 14, 2023

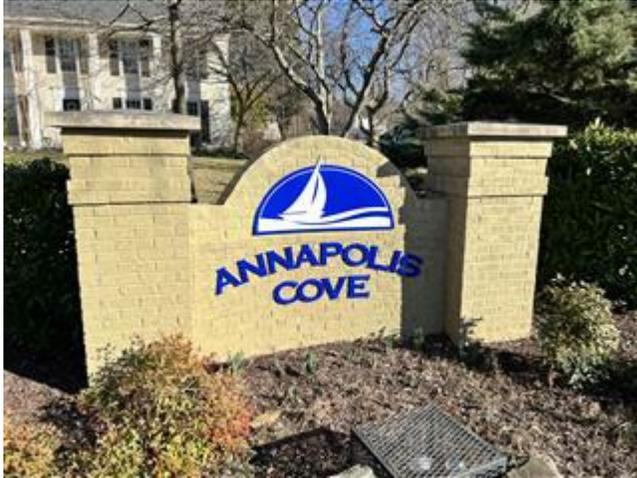
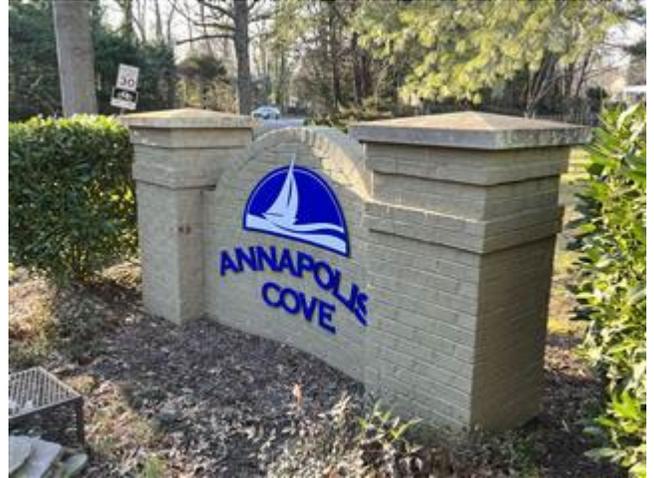
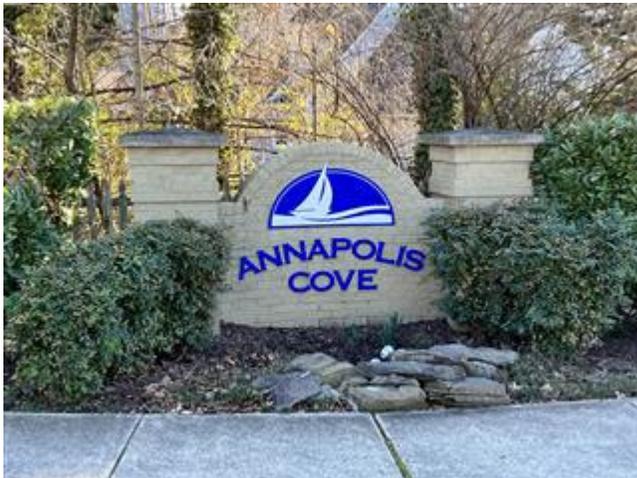
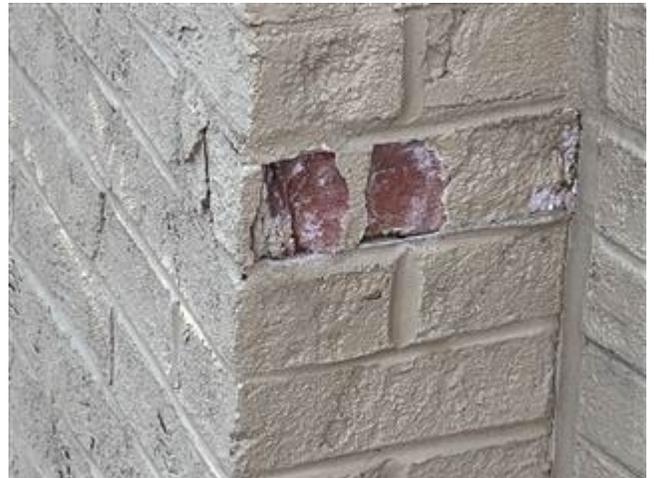
Entry Monument and Signage. The Association maintains three entry monuments with piers, all located along Bay Ridge Road at both ends of Catrina Lane and Chrisland Drive. The monuments are made of brick with cast stone pier caps, and they appear in good condition, with open masonry joints and loose or broken masonry units. The cast stone pier caps are discolored from tree mold and pollution.

We recommend re-pointing and replacement of defective areas of the masonry as needed. The Association has applied a coating of Siloxane or other sealants to mitigate water penetration and further degradation of the masonry work.

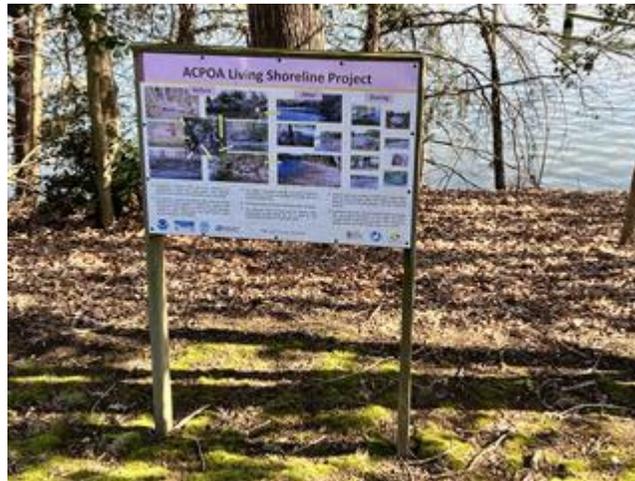
The info-graphic placard is made of wood and appears in good condition, with no noted damaged areas or weathering. We recommend that the Association replace the sign as required to keep the placard and graphics fresh and appealing.

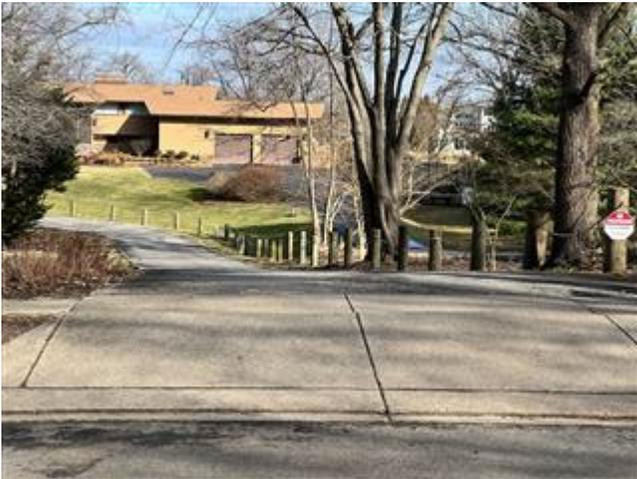
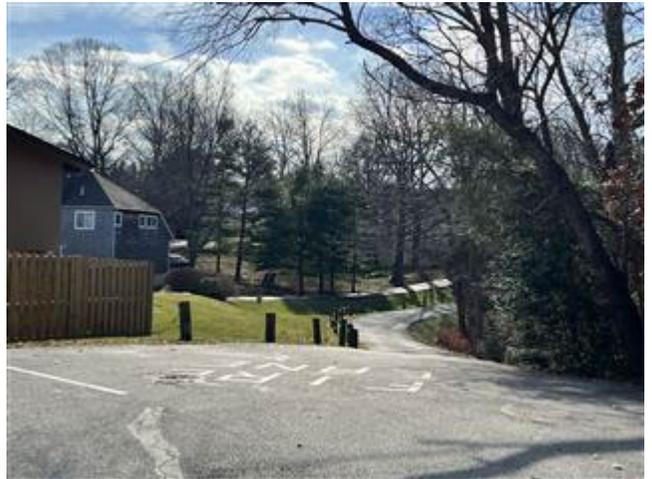
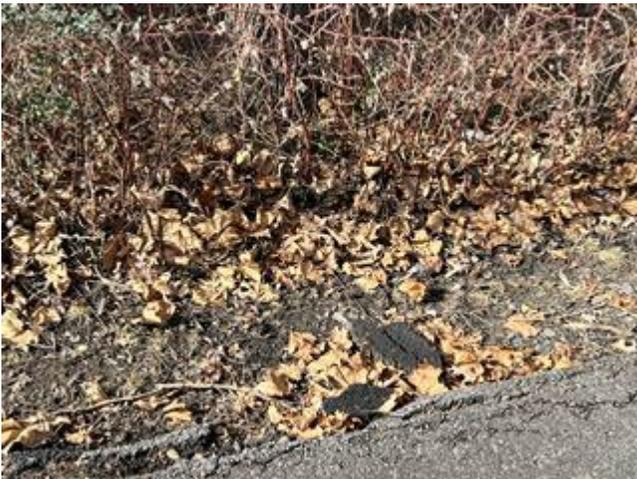
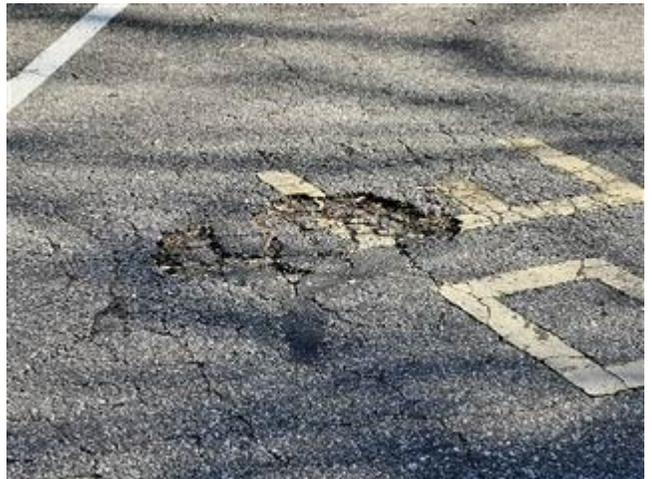
Asphalt Pavement. The Association shares responsibility for the asphalt paving at the recreation area. The recreation area site includes asphalt pavement for vehicle access and parking. In general, the asphalt pavement is in fair to poor condition with multiple areas of defects. The Association shares responsibility with the Annapolis Cove Marina for an inventory of approximately 17,200 square feet of asphalt pavement in a 75% (HOA) 25% (Marina) split.

The defects noted include the following:

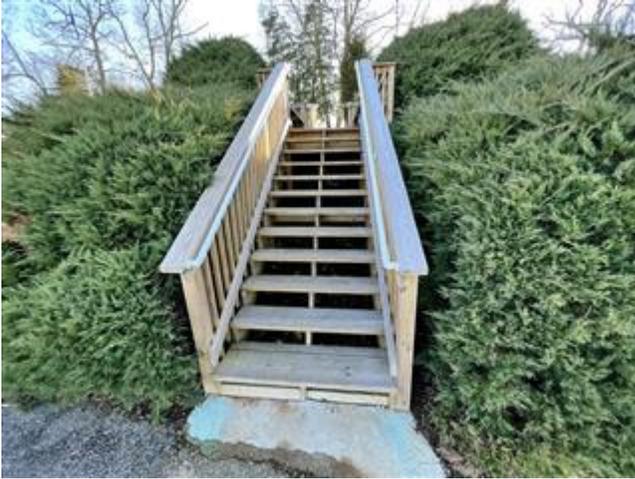
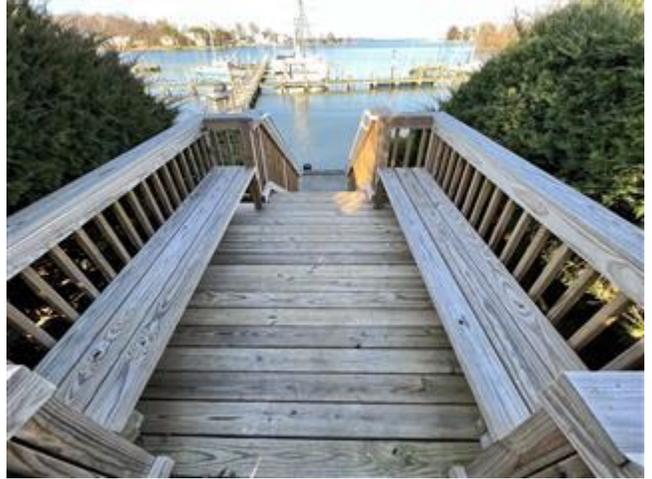
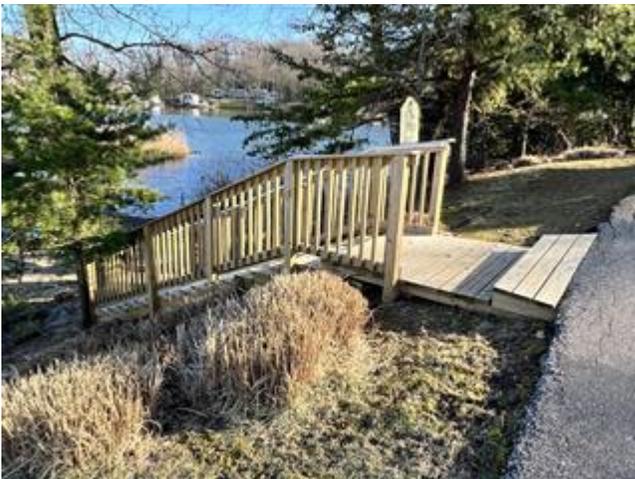
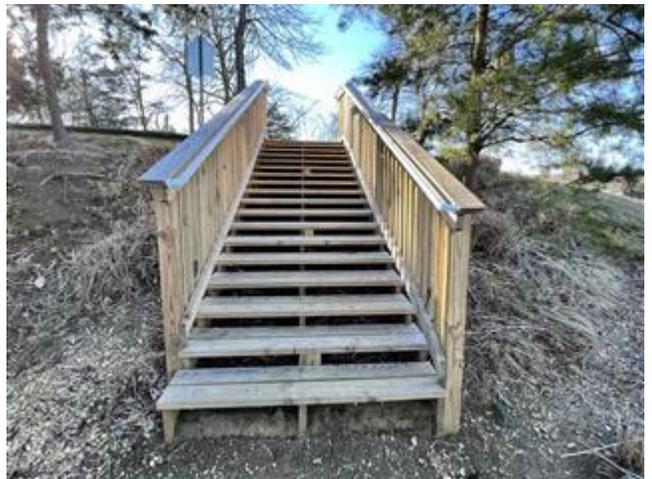
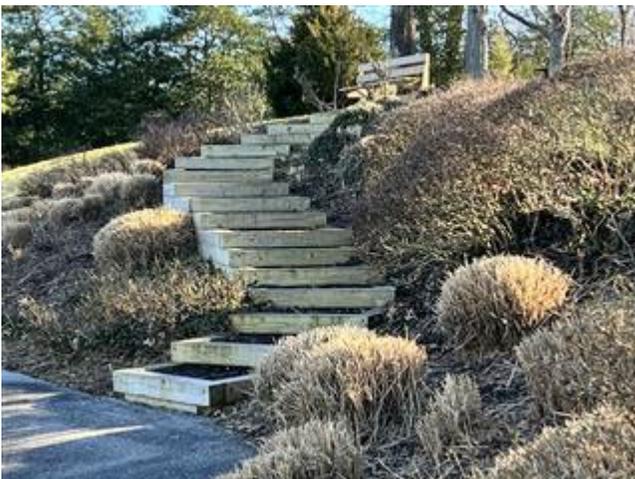
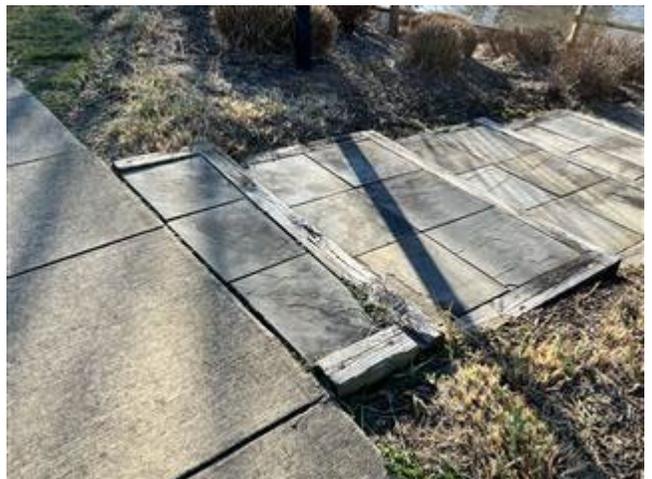
- The new stairs in the recreation area were installed in 2022 and appear in excellent condition with no noted defects.
- The pond observation stairs were installed with the original development in the late 1980s, and the wood appears in poor condition. The wood borders have moderate to extensive deterioration, including cracking, rot, and failed fasteners.

- Rot. Although the steps are constructed from treated lumber, we noted several locations where the boards are rotting.
- Cracks. Pressure-treated lumber will crack with exposure to repeated drying cycles. When the cracking becomes excessive, it can pose a trip hazard. We noted numerous locations where the cracking in the step surfaces poses a trip hazard.

We have separated the steps into the structure, decking, and railing components in the Reserve Analysis to reflect the different service lives of these components.

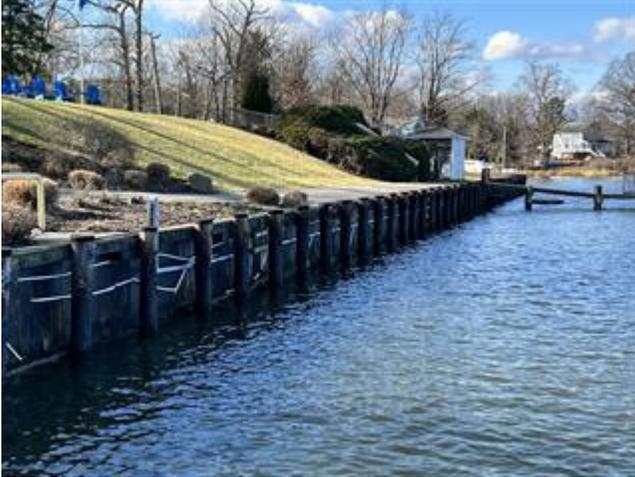
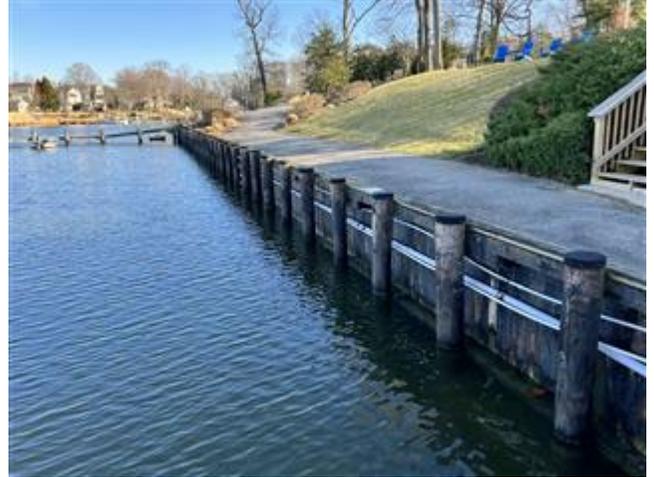
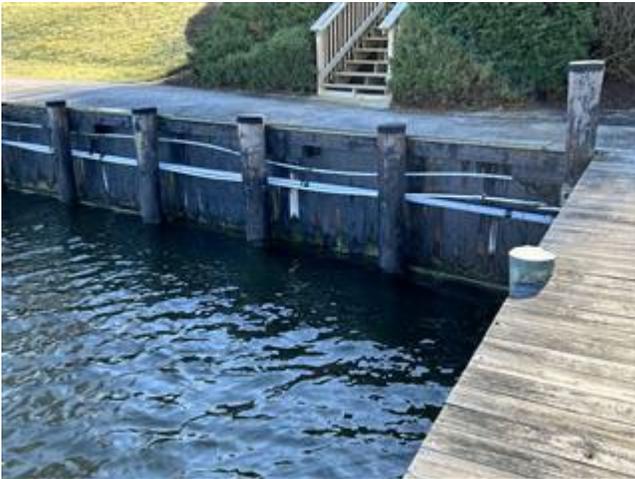
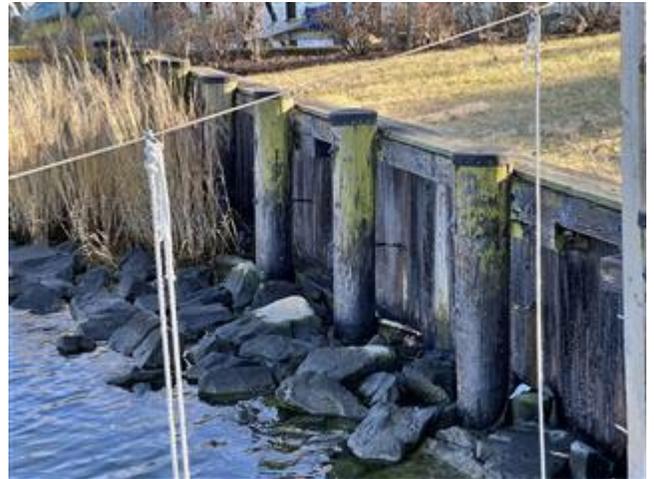
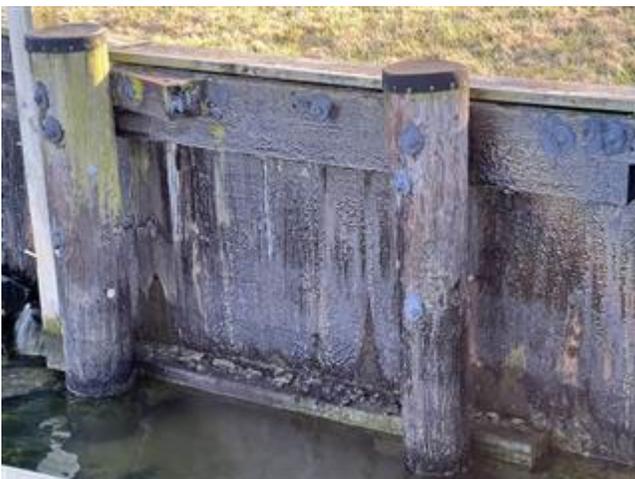
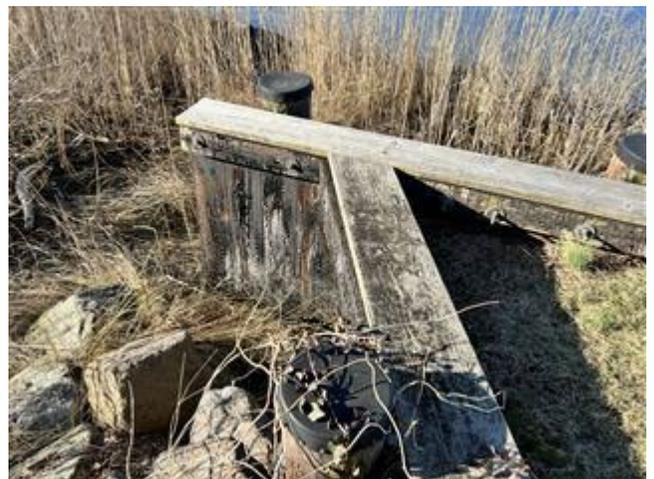
Wood Bulkhead, Stone Revetments, and Living Shoreline. The Association is responsible for approximately 360 linear feet of shoreline creosote-treated wooden bulkhead and 600 linear feet of a stone revetment along the waterfront portion of the community to help control beach erosion. The bulkhead repair and maintenance are paid for by a special grant and are assessed via homeowners' taxes, which will be paid off in 2030. [3/24/2023] Revised.

We recommend that the wood bulkhead be inspected at least once yearly and immediately following a storm that exposed the wall to significant wave action.

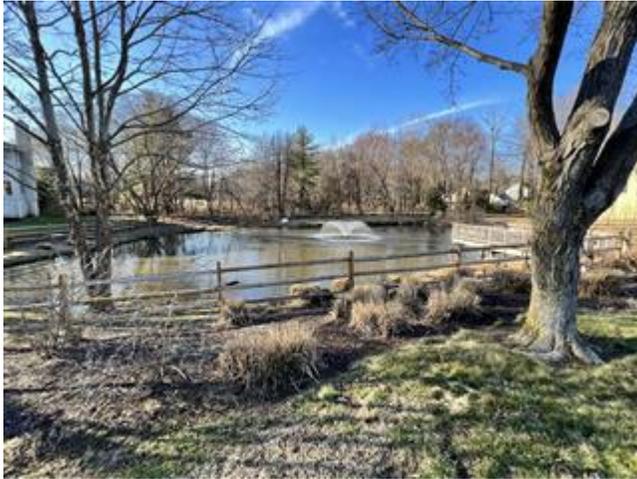
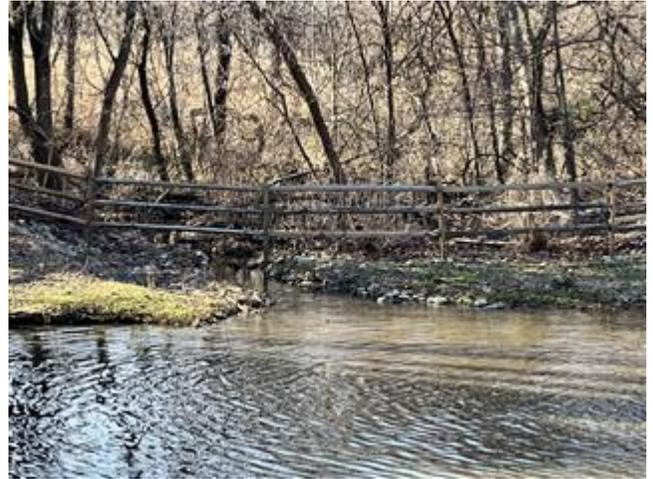
Stormwater Pond. The community is served by one stormwater management pond along Chrisland Drive. The pond is an area of approximately 1700 square yards and appears to be in fair condition. The pond is aerated by a two-horsepower fountain replaced in 2022. We noted no accumulated algae growth and could not see below the water. Inspections of ponds for compliance with regulations are beyond the scope of this study and are excluded. Pond inspection should be performed by a qualified professional.

Ponds will accumulate silt over time and lose the ability to store stormwater at design levels, which could result in overflows and minor local flooding. In addition, water quality can be negatively affected by increased siltation and debris accumulation. Accordingly, ponds require periodic dredging.

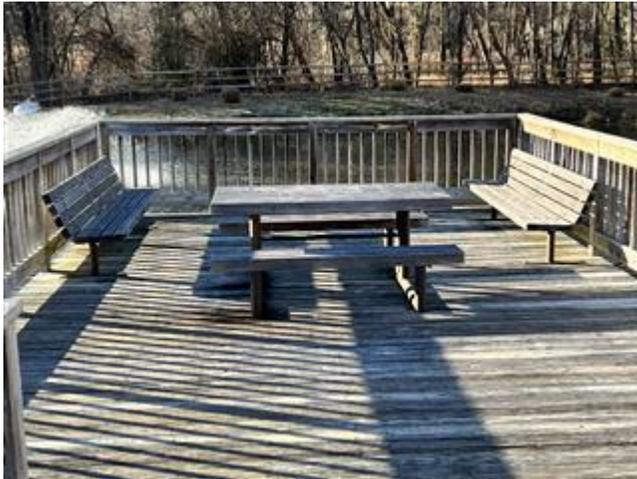
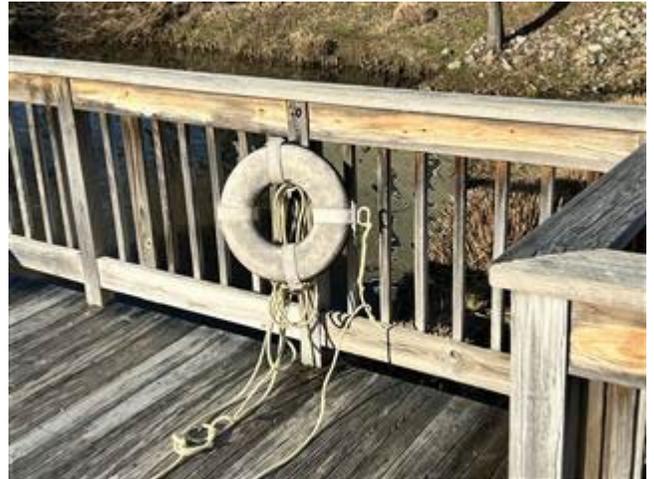
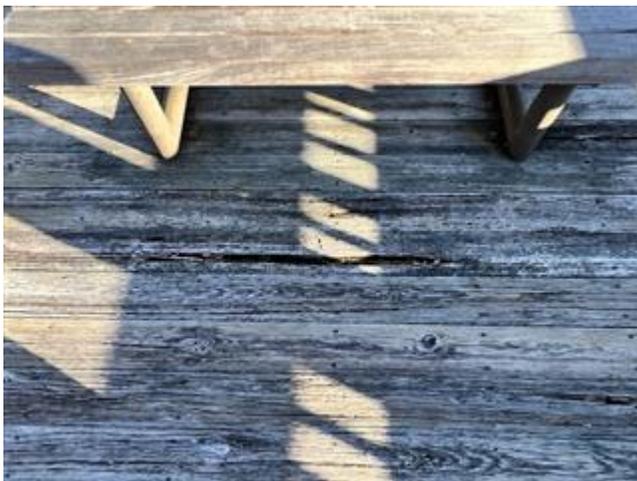
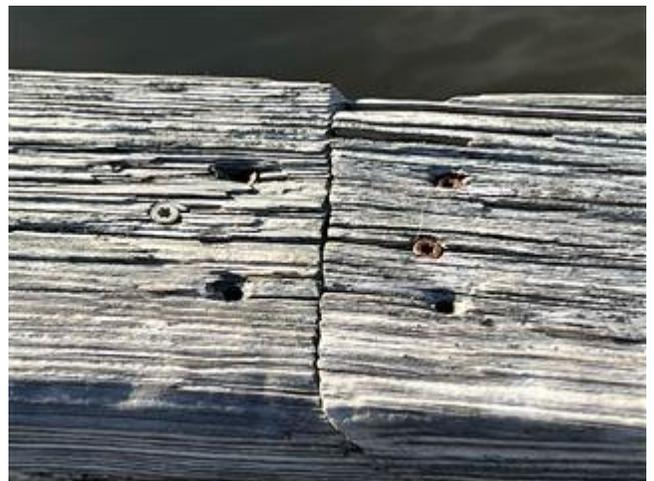
Observation Pier. The Association is responsible for approximately 420 square feet of an observation pier at the stormwater management pond on Chrisland Drive, and it appears to be in fair condition. In addition to minor discoloration, splitting, and rot, we noted that the ring buoy is weathered.

- **Observation Pier Decking.** The wood decking on the pond observation pier is exposed to harsh sun and weather extremes. It will typically require replacement before the heavier members of the underlying structure. This decking will also be removed and replaced when the underlying structure is replaced. To model this replacement pattern, we have provided a complete replacement incident to replace the structure. We have included an additional replacement interval for the wood pier decking at the midpoint of the service life of the underlying structure. The wood pier decking appears to be in poor condition.

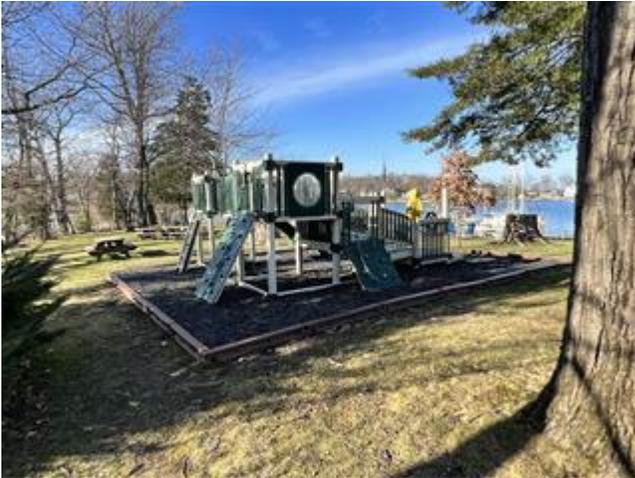
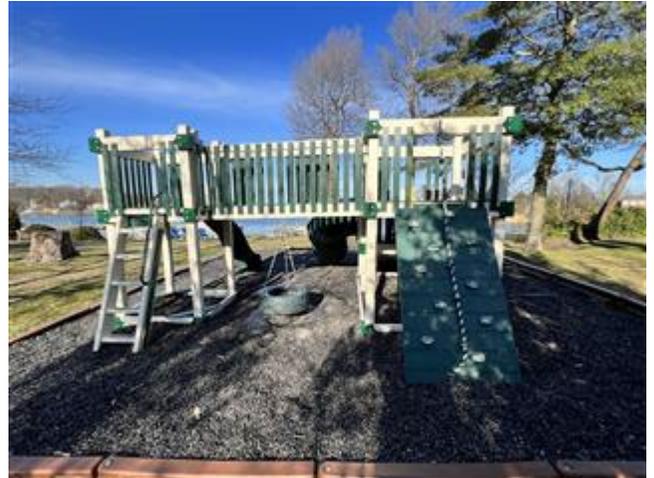
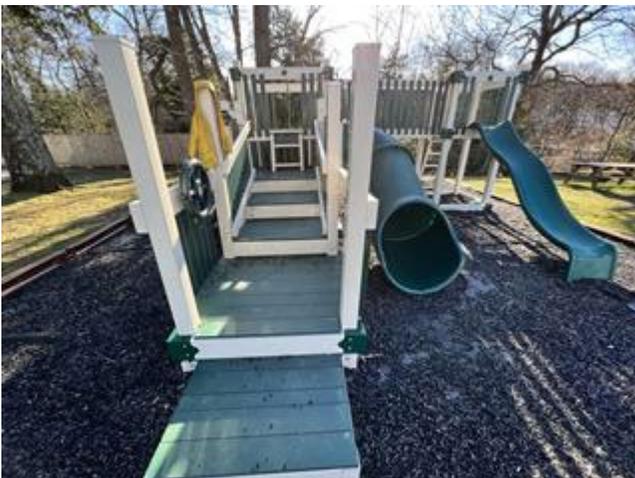
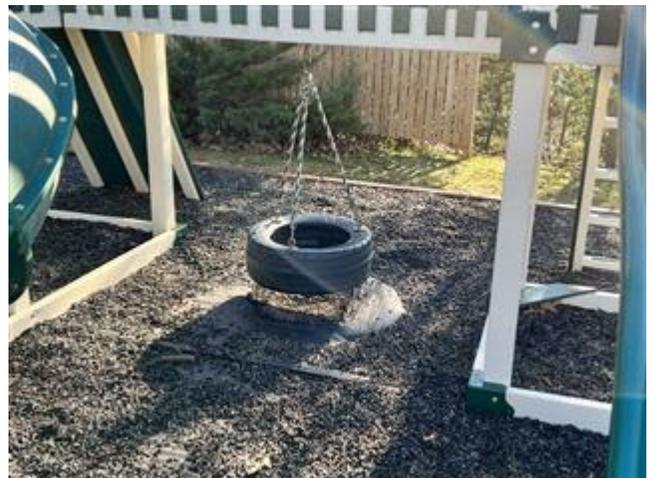
Tot Lots. The community maintains one tot lot located in the Marina area. The tot lot includes play structures, miscellaneous play equipment, synthetic borders, and a rubber chip surface. The facility facilities appear in good condition with minor wear and no noted loose connections. We noted cutting, entanglement, falling, or tripping hazards. The plastic border appears to be in good condition. The rubber chip surface is displaced or missing or does not appear to be adequate. We recommend a swing wear mat be installed under the tire swing.
