LEVEL 1 REPLACEMENT RESERVE REPORT FY 2023

ANNAPOLIS COVE MARINA

January 18, 2023

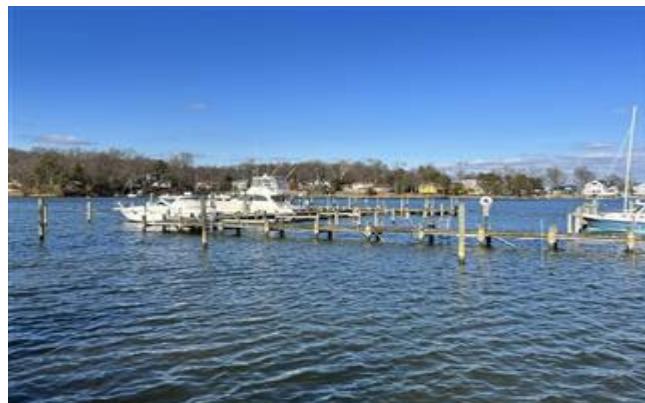
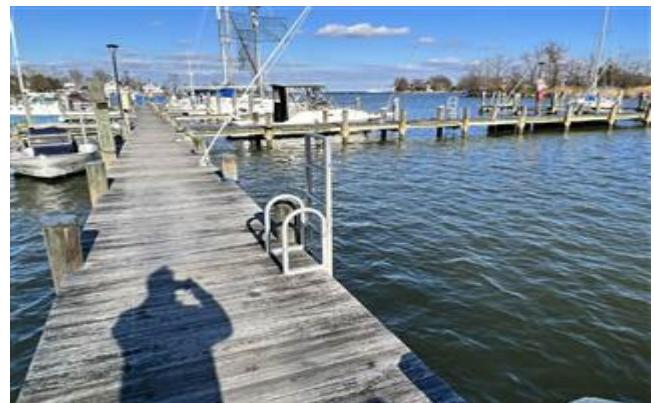
Wood Pier Decking. The wood decking on the pier's trunk, stems, fingers, and wave attenuators are exposed to harsh sun and weather extremes. It will typically require replacement before the heavier members of the underlying structure. This decking will also be entirely removed and replaced when the underlying structure is replaced. To model this replacement pattern, we have provided for a complete replacement incident to the replacement of the structure, and we have included an additional replacement interval for the wood pier decking at the midpoint of the service life of the underlying structure.

The wood pier decking appears to be in fair condition with some signs of discoloration and rot.

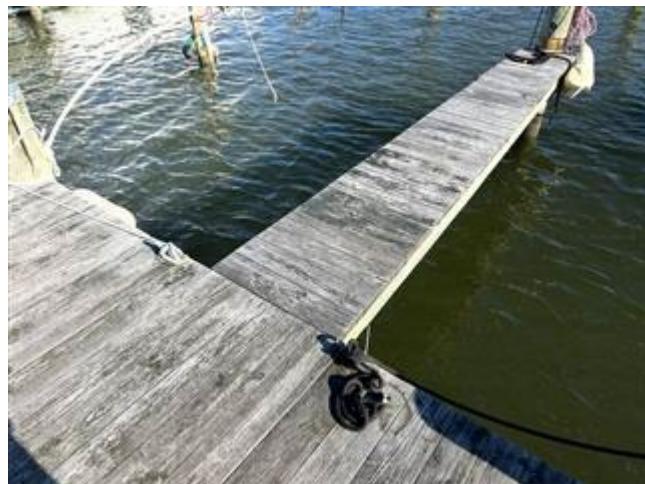
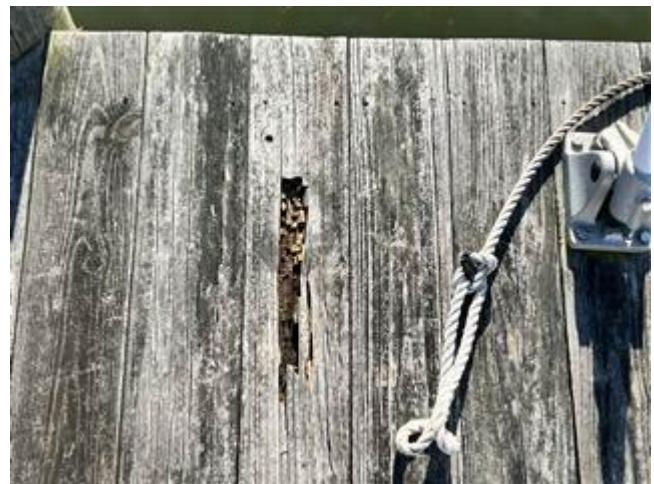
Pier Structure. The structure consists of pressure-treated woodpiles on 10-foot centers with stringers spanning the distance between piles. We have assumed that all pilings will be replaced as needed.

The pier structure appears in good condition and was replaced approximately 10 years ago. We noted some rot on the pilings.

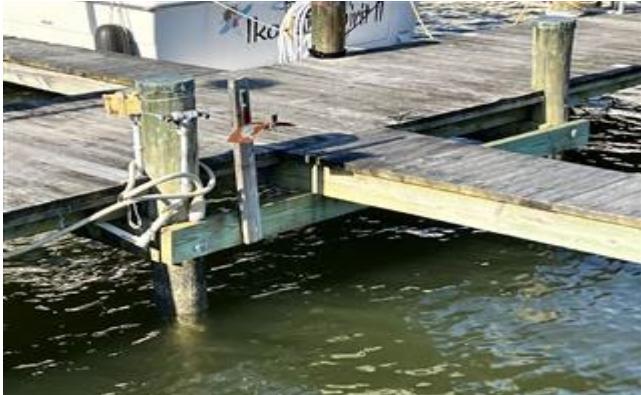
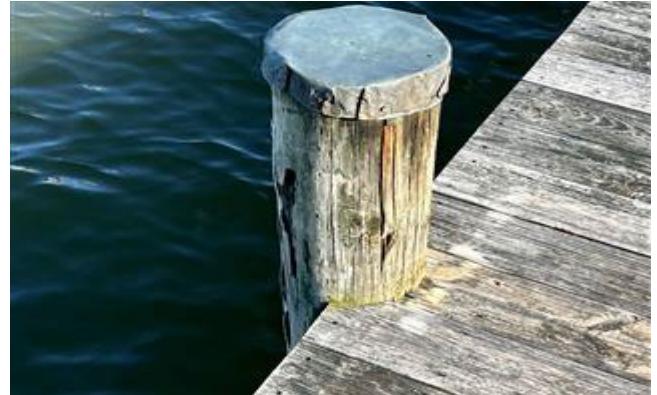
Freestanding Pilings. Freestanding pilings are those pilings that are installed at the outside limit of each slip. These pilings provide mooring points to secure the stern of the boat within the slip. They are not a part of the pier structure. Because these pilings can be replaced individually when required without affecting other elements of the pier structure, we have treated them as being replaced as needed and spread the cost of their replacement over time.

The freestanding pilings appear to be in fair condition with moderate vegetative growth and minor rot at the water level.

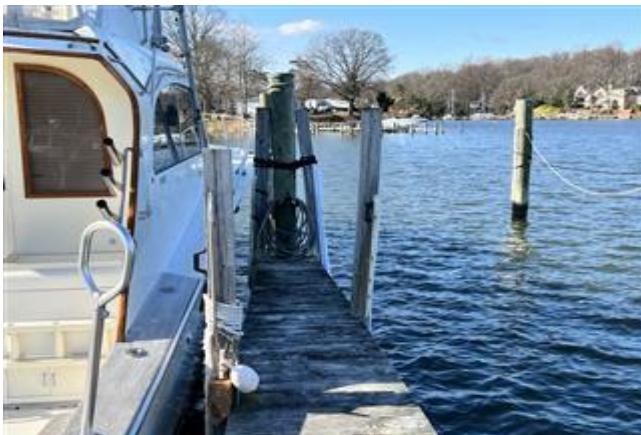
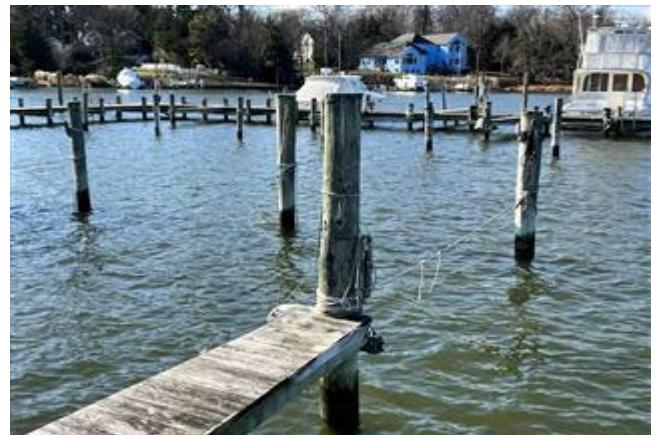
Wave Attenuation. The pier includes wave attenuators across the ends of the stems. Wave attenuators are installed on the water with part of the attenuator remaining at and above sea level and the bottom half reaching underwater to reduce the energy and impact from incoming waves.

The wave attenuators are reported to be in poor condition, and the Association plans to replace them in phases to spread out the cost.

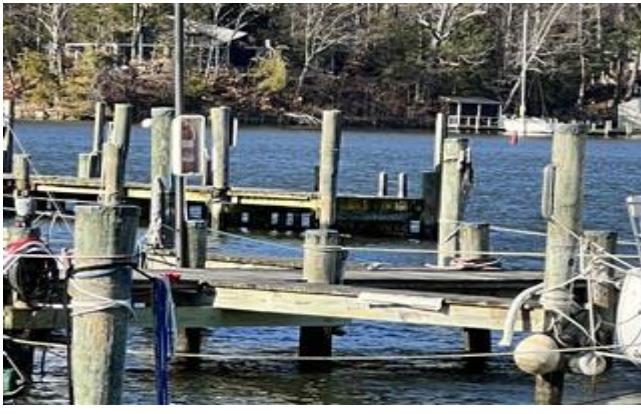
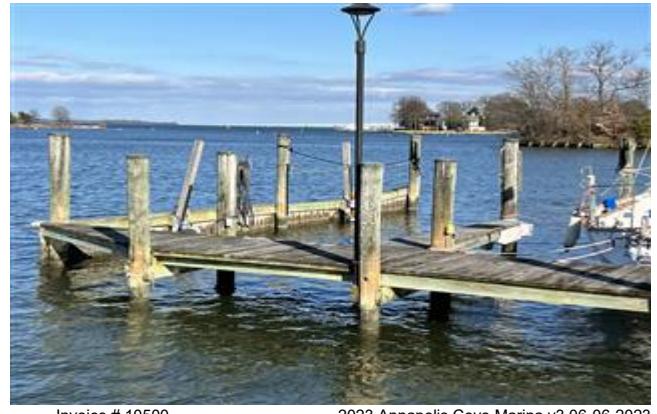
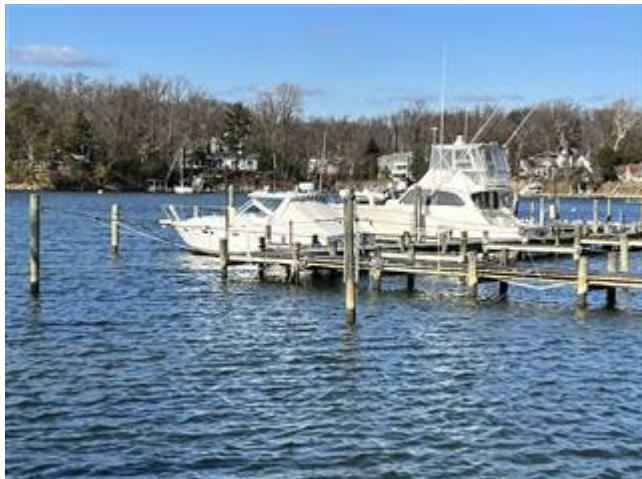
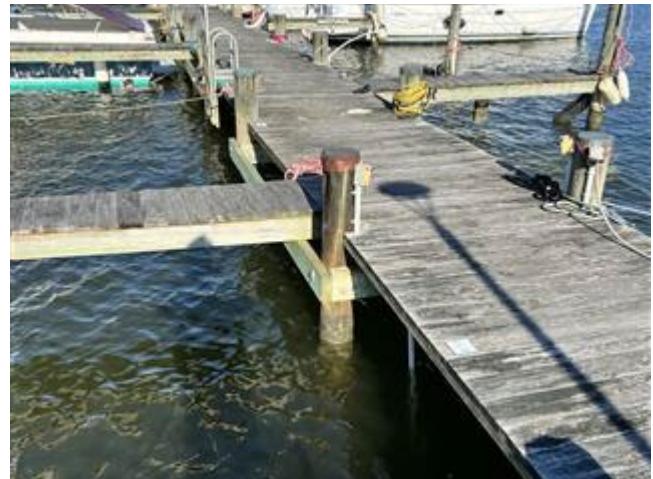
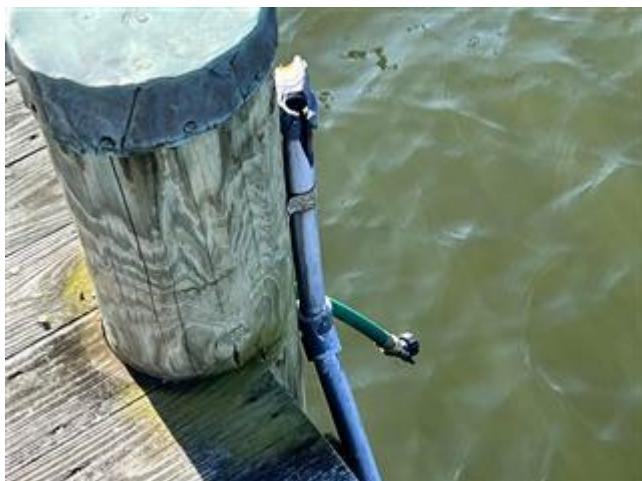
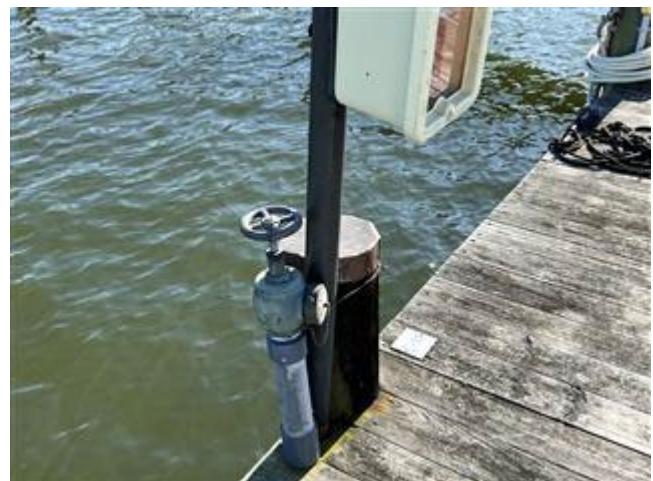
Pier Utility Systems. The pier includes lighting, electrical outlets, water supply, and fire suppression standpipe utility systems. We have assumed that the utility systems will be removed and replaced when the pier structure is replaced. We have also assumed that the systems will be replaced at the midpoint of the service life of the pier structure.

The pier utility systems appear to be in mixed fair to poor condition with rusted electrical panels, pitted light poles, broken or missing hose bibs, and broken or poorly supported water piping. The fire standpipe and electrical outlets appear to be in fair condition

It is recommended that all piers be inspected at least once each year to identify damage to pilings, structural members, surface boards, and railings.

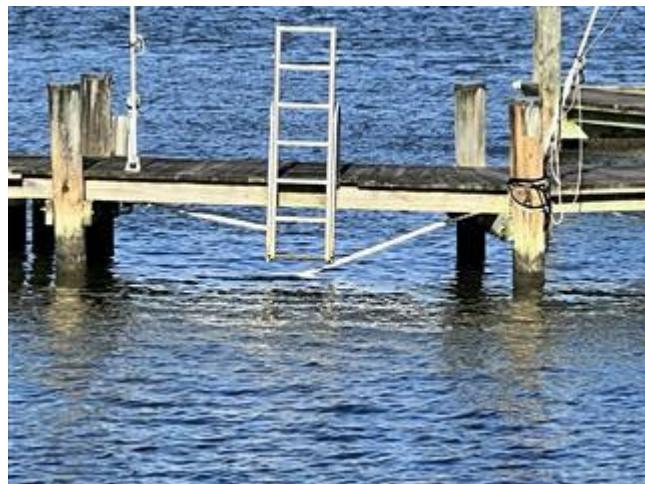
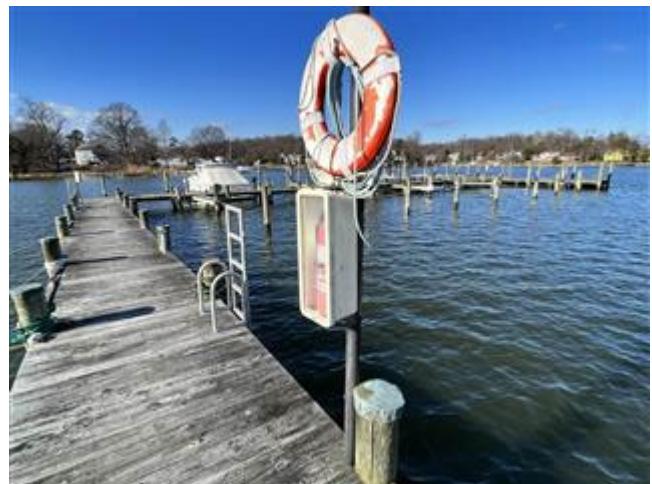
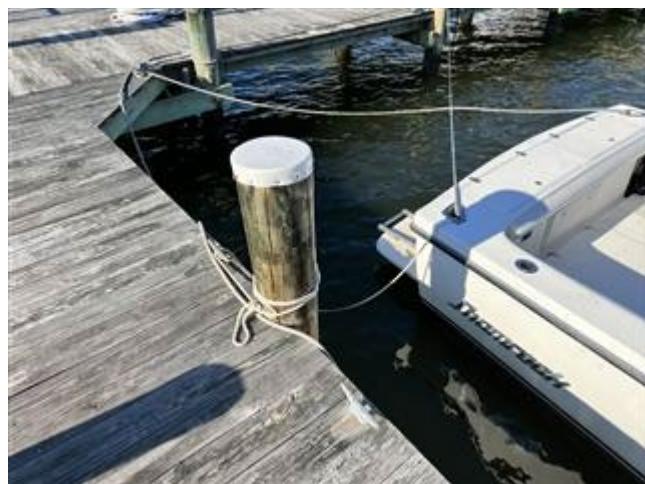
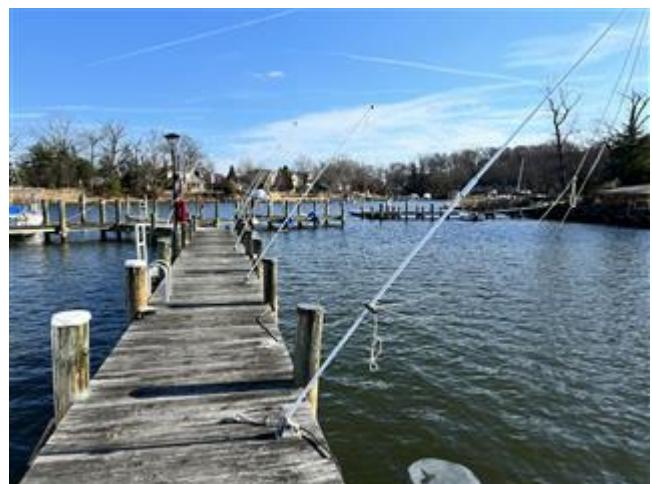
Miscellaneous Pier Components. We have included pier ladders, piling caps, bubblers, and mooring whips in the reserve funding, but have excluded minor components such as wooden gates, lines, cleats, bumpers, rub rails, and ring buoys. Some of the ring buoys appear to be faded from weather and UV damage. The ladders, whips, and piling caps appear to be in fair condition.

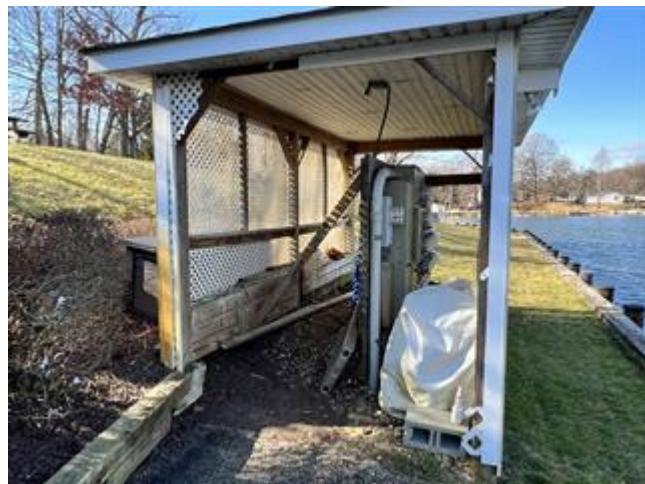
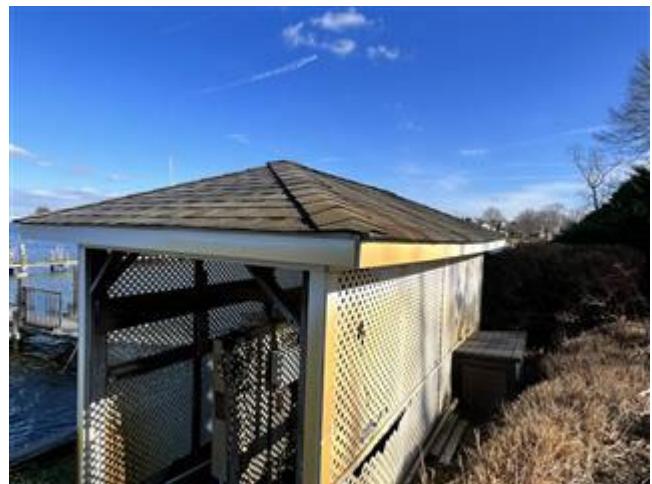
Sheds. The Association owns an open wooden pavilion shed with an asphalt shingle roof that houses the electrical service/meters, compression tank, and for storage of the pump-out system and cart. The shed appears in good condition with minor defects in the polyvinyl chloride plastic (PVC) lattice.

We noted some erosion and mitigation measures at the ground level on the uphill side of the shed and some tree mold on the wooden trim, but no curled, broken, or missing shingles on the asphalt shingle roof.

We have assumed that the components of the shed's exterior will be replaced as needed, and when a complete replacement is required, it will be replaced with a similar type and size.

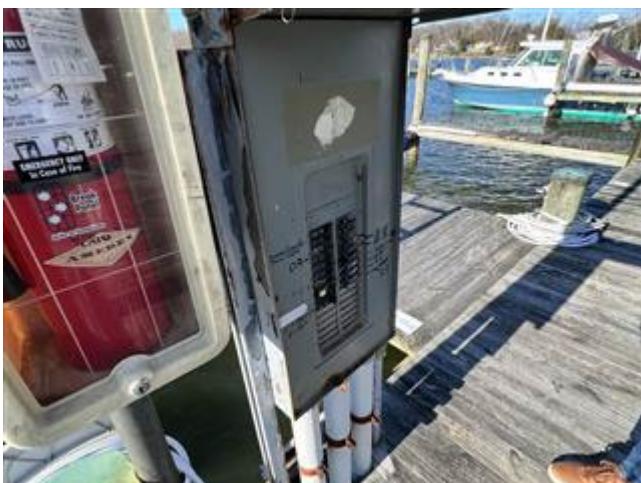
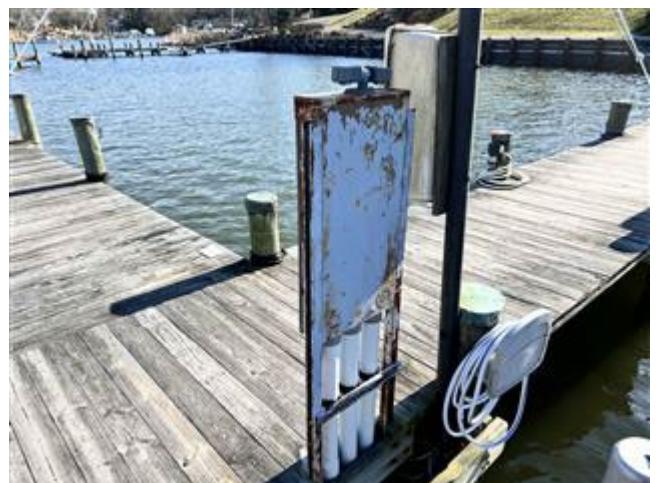
Electrical Distribution Panels. The marina has an electrical distribution panel located on the trunk of the pier. This panel separates the marina's electrical power feed into separate circuits while providing protective circuit breakers for each circuit. This panel dates to the original construction of the pier and has a rated service life of 50 years or more.

The overall condition of the distribution panel appears poor with rust on the weatherproof metal cover. As the distribution panel ages, obtaining replacement parts can be expected to become more difficult. When parts are no longer available, the Association will have to replace the existing panels. Therefore, we have included funding in the Reserve Analysis for distribution panel replacement.

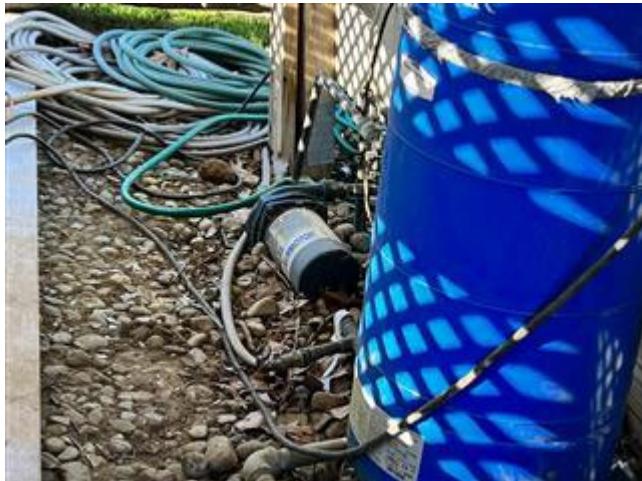
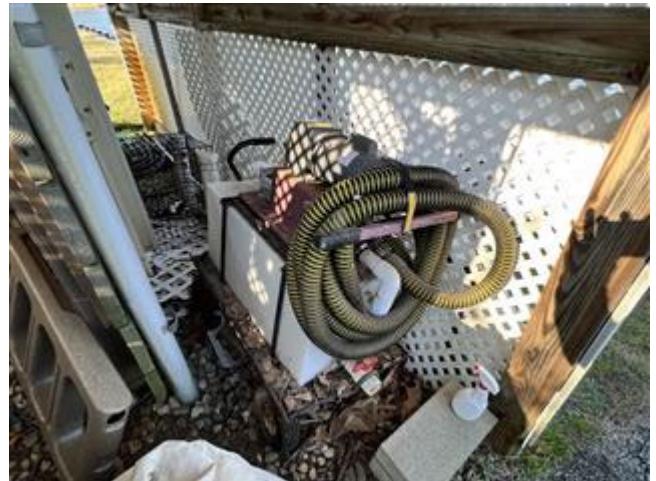
Wells, Pumps and Tanks. The marina water is supplied by a well and submersible well pump with a pressure tank in the shed. The marina sewerage disposal is provided by a cart-mounted pump-out unit and tank stored in the shed.

The cart-mounted pump-out pump and water tank are reported to be in good operating condition and have an expected life of 5 years.

We have included three items in the Reserve Analysis for the well and water pump: the replacement of the pump, tank, and the well at the end of its rated service life. The water was winterized and not on at the time of the survey, but the system is reported to be in good operating condition. The expected life of the well is 50 years, and the pump and tank are 15 years.

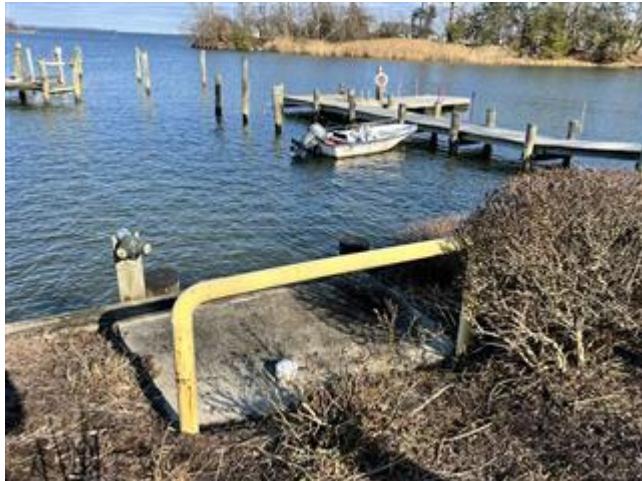
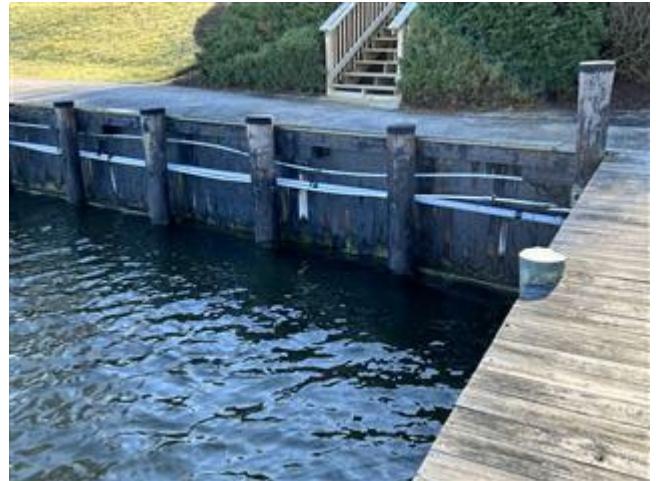
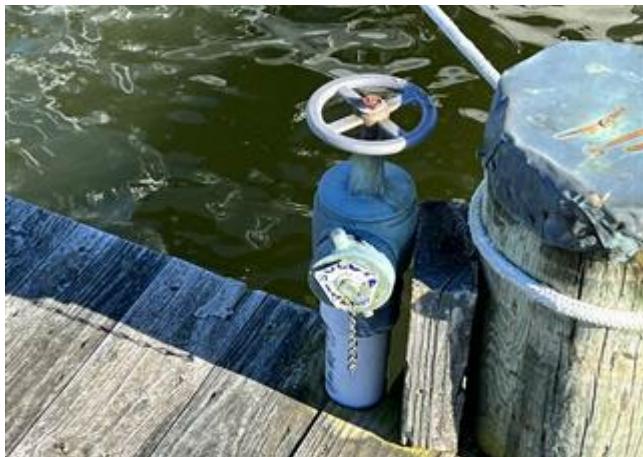
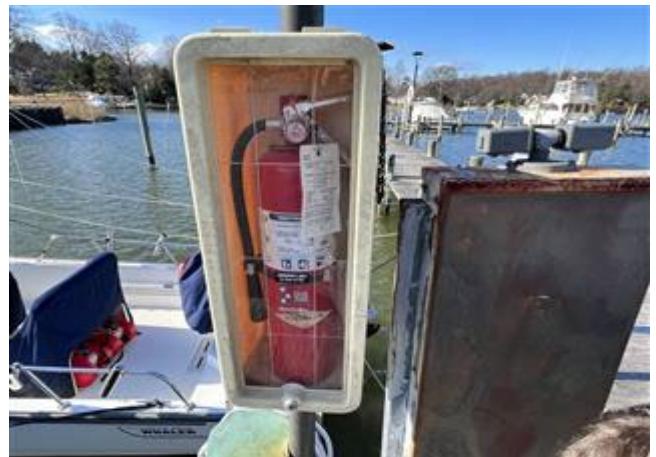
Fire Safety Systems. The marina is fitted with a fire safety system that includes a concrete fire department water tank, Siamese connection, dock standpipes, and fire extinguishers in cabinets, and these systems are reported to be operating normally. Testing and inspection of fire safety systems are not included in this study.

For dry pipe systems, we have assumed that these are long-life components and will not require whole-scale replacement. It is imperative however for these pipes to be properly drained or for the water to be properly conditioned. Other components such as heads, gauges, and valves are assumed normal maintenance items and are therefore excluded from the study.

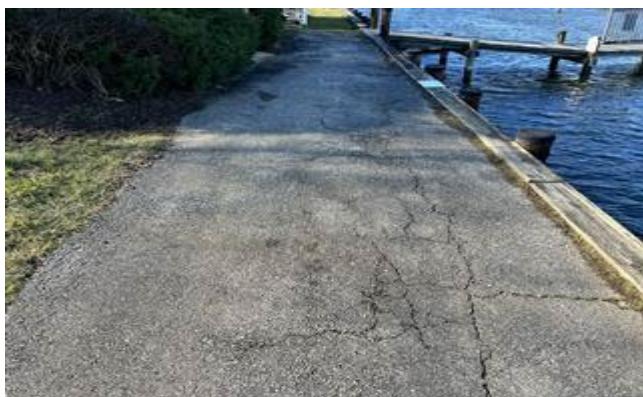
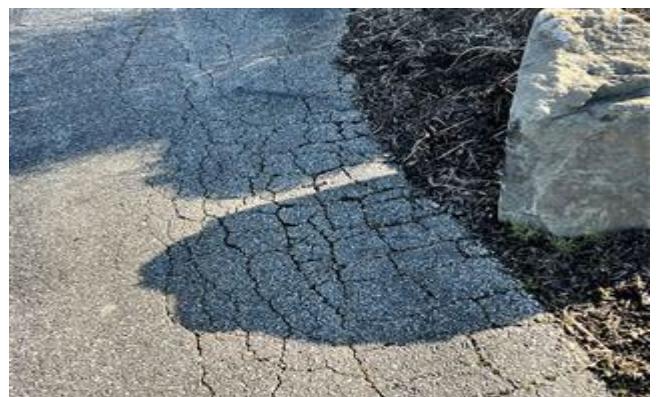
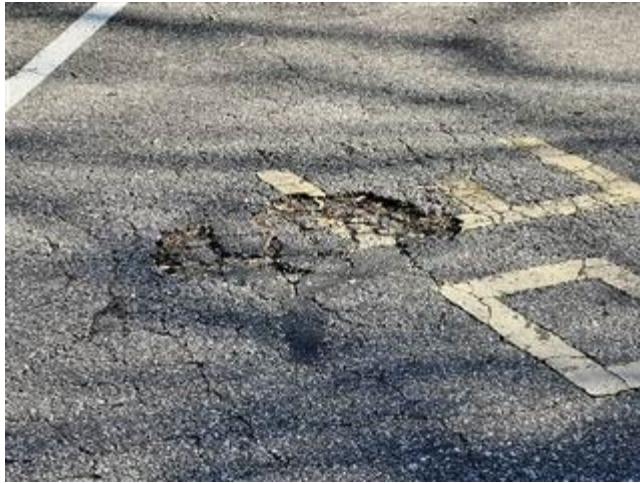
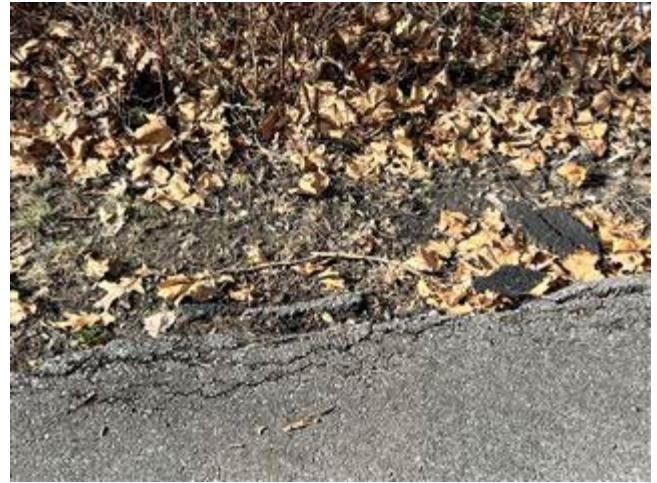
Asphalt Roads and Parking. The Associations maintain an inventory of approximately 16,000 square feet of common asphalt driveways and parking in the community. The overall condition of the asphalt drives appears fair.

The defects we noted include the following:

- Open Cracks. There are multiple locations where open cracks allow water to penetrate the asphalt base and the bearing soils beneath the pavement. This water will erode the base, accelerating the deterioration of the asphalt pavement. If the cracks have allowed the deterioration of the base materials and the bearing soil, the damaged areas should be removed and replaced. All other cracks should be cleaned and filled.

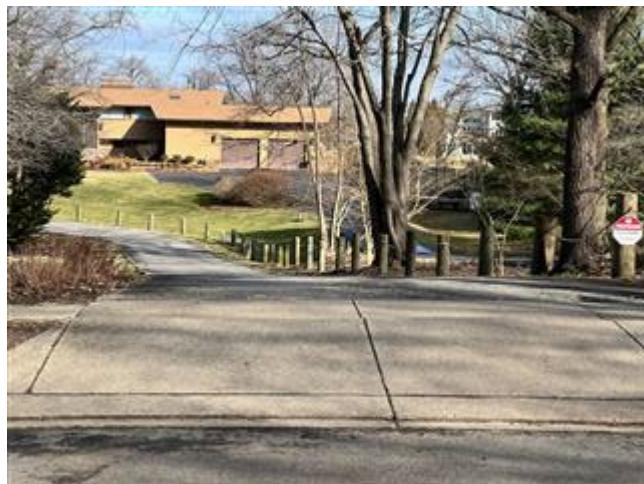
Guard Rail. We have included the PTL round post guard rail with rope cable installed along the marina access road. The guard rail appears to be in good condition. the surrounding ground at the guard rail posts should be inspected periodically to ensure that the soil is intact and compacted. Any damaged sections of the cable or posts should be replaced to ensure the system performs adequately.

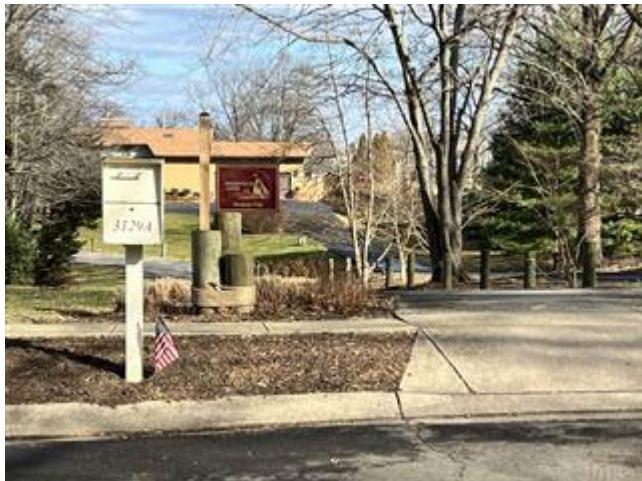
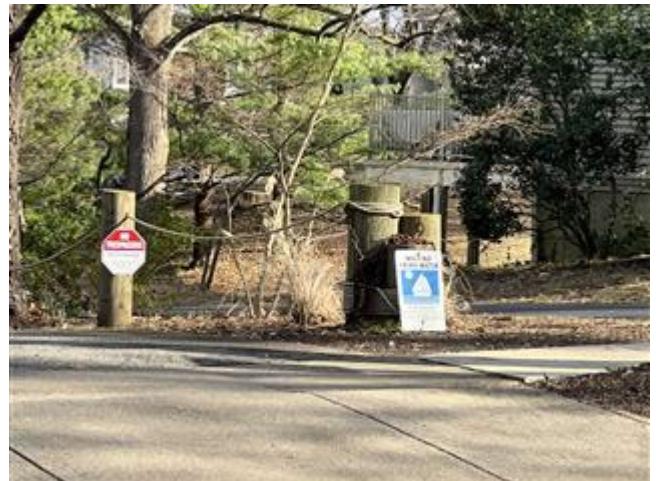
Entry Monument and Signage. The Association maintains two entry monuments with piers consisting of three PTL lumber piling posts bound with rope cable. The Monument piers appear to be in good condition with no noted defects.

The monument signage and lettering are made of carved wood material and are expected to have a useful life of 20 or more years. The entrance monument signage appears to be in good condition.
