LEVEL 1 REPLACEMENT RESERVE REPORT FY 2023 ANNAPOLIS COVE HOA

ANNAPOLIS COVE HOA

ANNAPOLIS, MARYLAND

February 14, 2023

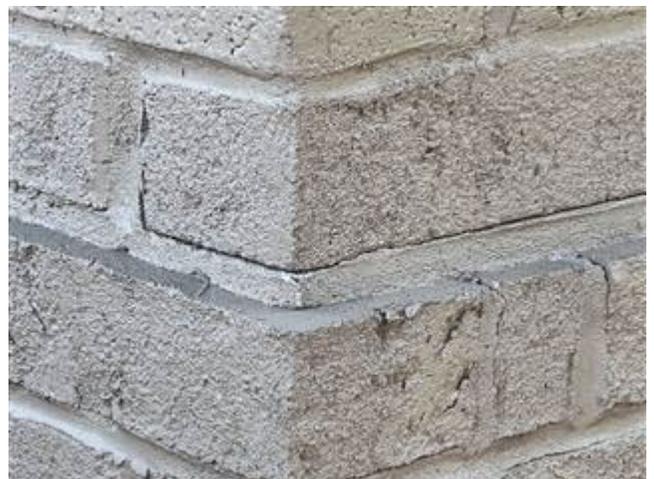
The monument sign and lettering appear metal and is expected to have a useful life of 25 years. Acrylic or other synthetic material is expected to have a useful life of 10 to 15 years.

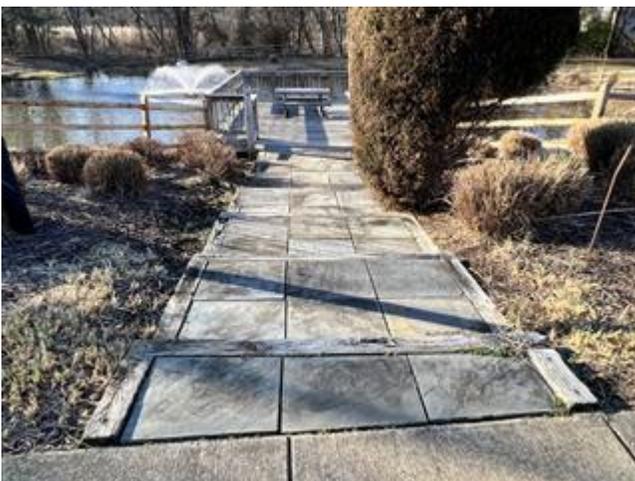
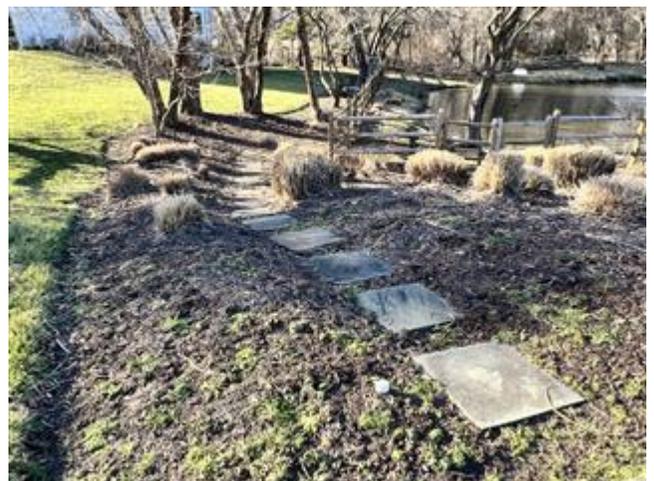
Flagstone Pavers. The Association maintains approximately 160 square feet of flagstone pavers at the pond area, and they appear in good condition. Flagstone pavers provide a solid, decorative, and renewable surface that is part of the community's steps and paths at the community observation pier on the pond at Chrisland Drive. They are observed to be in good condition, with areas of defects consistent with the age of the installation.

- Cracking. Cracked pavers, some of which are creating trip hazards.
- Settlement. Areas where pavers have settled due to a failure of the base under the pavers. This settlement can result in an uneven surface, posing a trip hazard.
- Ponding. Evidence of areas where water is ponding on the unit paver system due to settlement or poor drainage of the surface and surrounding area.

Flagstone pavers have a service life of 40 years or more if the system is maintained on a consistent periodic basis. Eventually, the system will require a large-scale replacement; identical flagstone pavers may not be available, and it is recommended that the flagstone pavers be replaced.

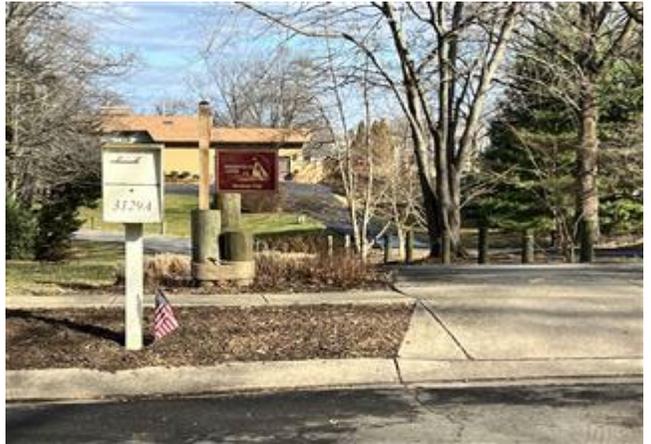
Site Lighting. The Association operates the pole light at the recreation area parking lot and three monument lights. The lights were not on during our site visit, but we understand they remain in good operating condition. We noted a broken fixture at the Chrisland Drive monument, and the other two monuments' lighting is protected from damage with an expanded metal cage.

This study assumes the replacement of the light fixtures every 15 to 20 years and pole replacement every 30 to 40 years. When the light poles are replaced, we assume the underground wiring will also be replaced. When a whole-scale lighting replacement project is called for, we recommend consulting a lighting design expert. Many municipalities have design codes, guidelines, and restrictions regarding exterior illumination. The Association should consider factors such as environmental sustainability, longevity, and cost when they look at the replacement of their lighting.

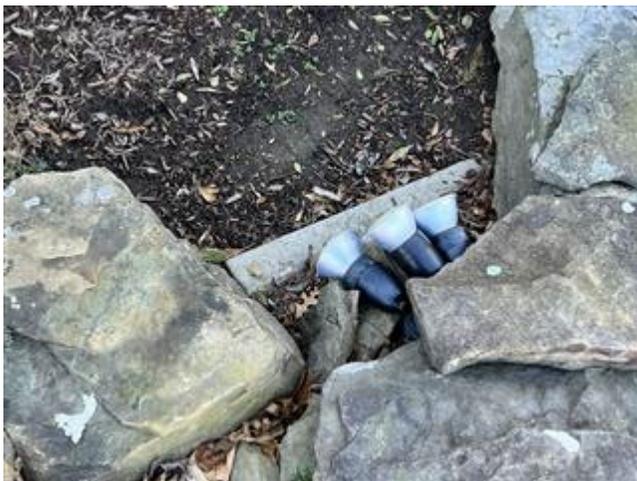
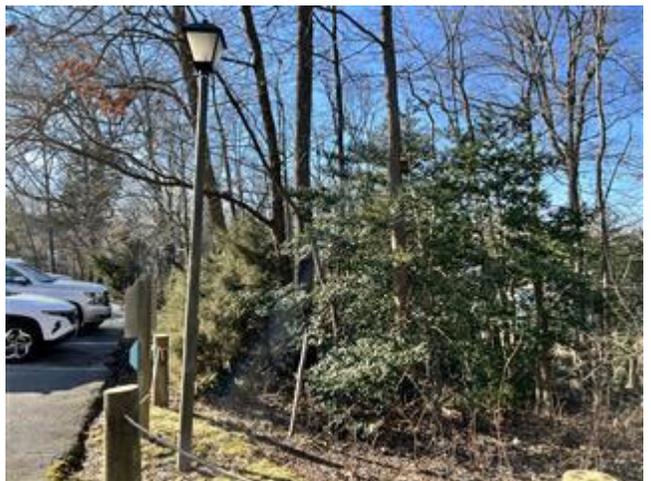
Site Electrical Equipment. The electrical systems of the site lighting are located at the entry monuments and the pond area for the fountain pump and are reported to operate normally. If protected from water damage or overloading, the

transformers, meters, and circuit breakers have a rated service life of 50 years and are considered long-life components. We have provided funds for their eventual replacement in the Study. We noted some loose receptacle boxes and light sensors at the monuments.

To maintain this equipment properly, periodic tightening of all connections is recommended every three to five years. Insurance policies, in some cases, may have specific requirements regarding tightening electrical connections. It is also recommended that outlets, sockets, switches, and minor fixtures be replaced at a maximum of every 30 years.

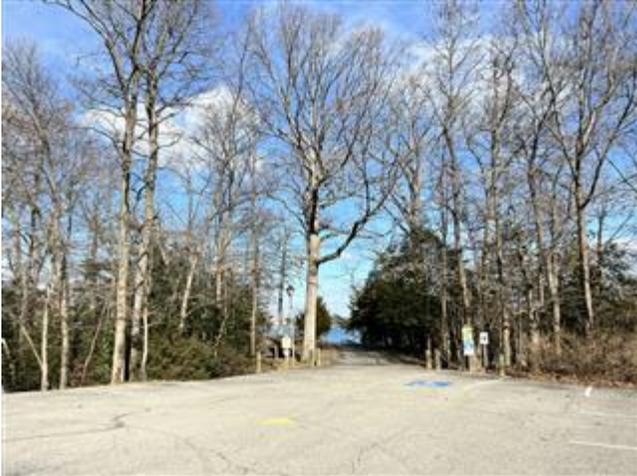
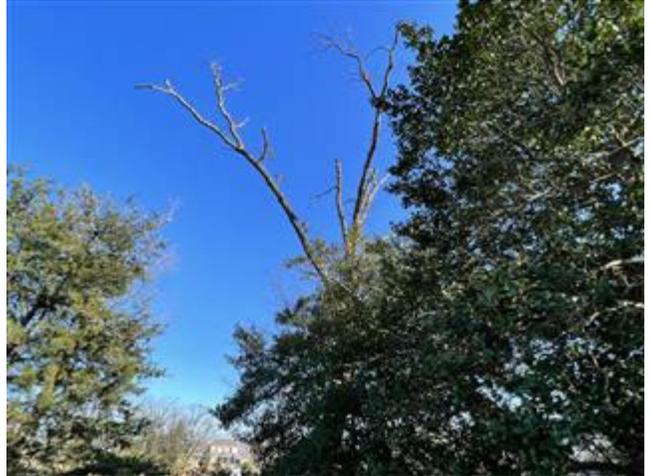
Tree Removal Allowance. We observed numerous locations where trees needed to be replaced in the common area.

We recommend that these trees be removed before the replacement of the tree. We have provided funding for removing the trees and tree roots. It must be understood that the funding provided is based on our understanding of the issues and our experience with similar projects. We recommend that the Association commission a study by an Arborist or company specializing in tree management to provide an inventory of the trees and plants within the community. Tree inventories are intended to provide basic information on the plant population of a property to make informed management decisions. Inventories can supply information on plant quantities, location, condition, size, and maintenance requirements. Based on this information, sustainable management plans and rational budgets can be developed for the property's care. We will adjust our figures to conform to professional studies and budget guidelines if the material or information is disclosed to us and/or made available.

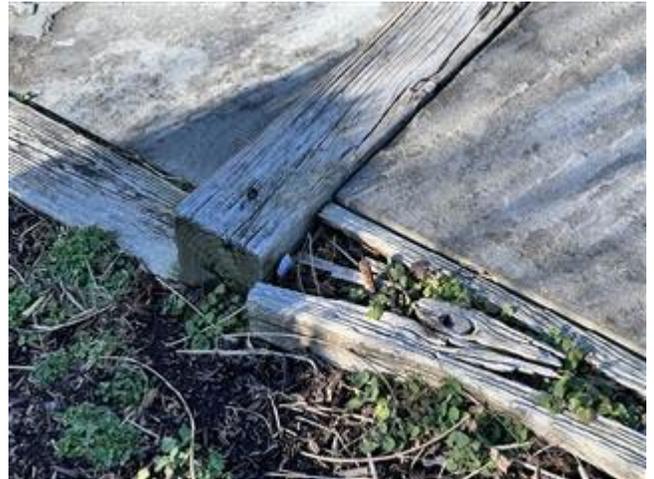
- Rot. Although the steps are constructed from treated lumber, we noted several locations where the boards are rotting.
- Cracks. Pressure-treated lumber will crack with exposure to repeated drying cycles. When the cracking becomes excessive, it can pose a trip hazard. We noted numerous locations where the cracking in the step surfaces poses a trip hazard.

When rebuilding these steps, the community may consider using engineered lumber instead of pressure-treated wood. While engineered lumber is one-third more expensive than pressure-treated wood, it offers the advantages of not splitting, cracking, creating splinters, or rotting. As a result, its rated service life is approximately 50% longer than the service life of pressure-treated wood.

It is recommended that the Association inspect all stairs at least once each year. All areas with moderate cracking or rot should be replaced. Areas covered with mold should be cleaned and treated.

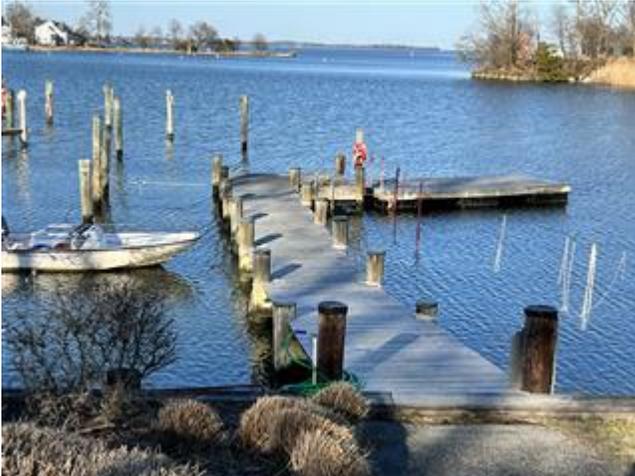
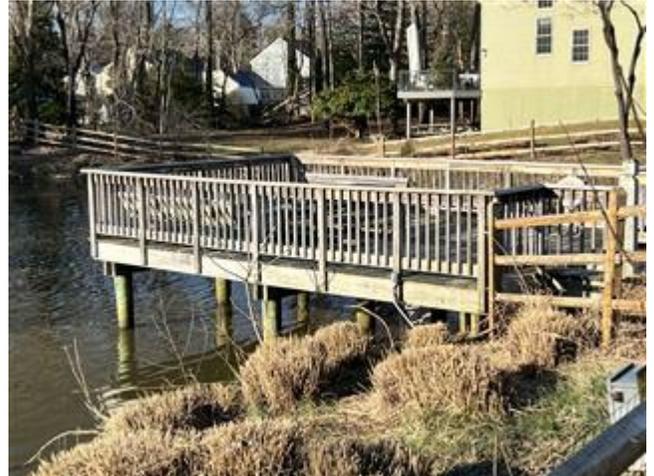
Wood Docks, Floating Platforms, and Observation Pier. The Association operates a boat dock, a floating dock, and an observation pier. The fixed dock and floating platform are in the recreation area, and the observation pier is at the pond on Chrisland Drive. The dock and pier are constructed from pressure-treated lumber supported by wood pilings. The floating platform is constructed from pressure-treated wood framing and decking and supported on plastic floats. The dock and piers are approximately 33 years old. New pier surfaces and railings were installed approximately 13 years ago. Pilings and decking are being replaced as needed. For the Reserve Analysis, we have separated each structure into three or four components, the wood deck, the structure, the pilings or floats, and the railing, to reflect their different service lives. It is recommended that all docks, platforms, and piers be inspected at least once yearly to identify damage to pilings, structural members, surface boards, and railings.

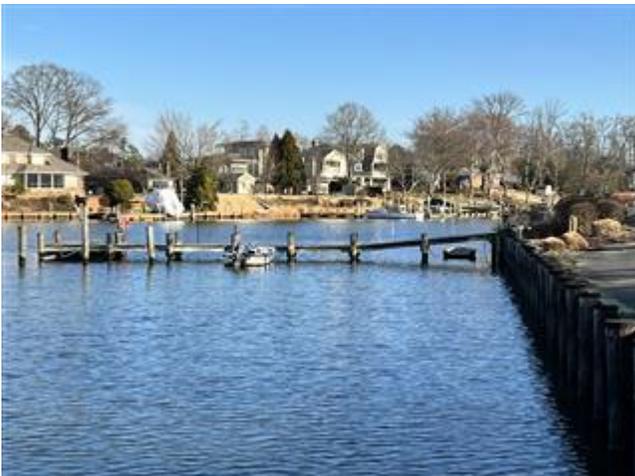
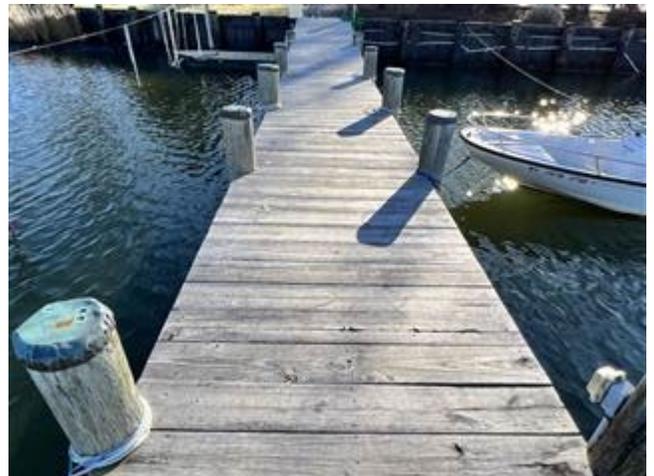
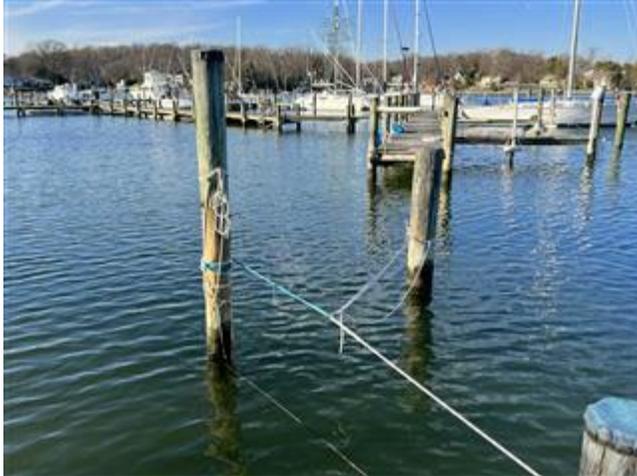
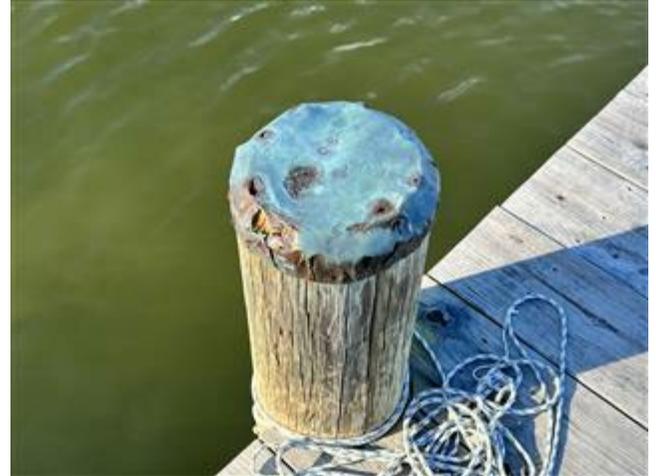
Wood Boat Dock. The Association is responsible for approximately 540 square feet of pressure-treated wood boat dock. The dock appears to be in overall fair condition.

- **Wood Decking.** The wood decking on the dock, the finger piers, and the wood walk are exposed to harsh sun and weather extremes. It will typically require replacement before the heavier members of the underlying structure. This decking will also be removed and replaced when the underlying structure is replaced. To model this replacement pattern, we have provided a complete replacement incident to replace the structure. We have included an additional replacement interval for the wood pier decking at the midpoint of the service life of the underlying structure. The wood decking appears in fair condition with minor defects consistent with age.

- **Dock Structure.** The structure consists of pressure-treated woodpiles on 10-foot centers with stringers spanning the distance between piles. We have assumed that all pilings will be replaced when the dock structure requires replacement. The pier structure appears to be in fair condition.

- **Freestanding Pilings.** Freestanding pilings are those pilings that are installed at the outside limit of each slip. These pilings provide mooring points to secure the stern of the boat within the slip. They are not a part of the pier structure. Because these pilings can be replaced individually when required without affecting other elements of the pier structure, we have treated them separately in the analysis and spread the cost of their replacement over time. The freestanding pilings appear to be in good condition. We noted holes in some of the pier caps.

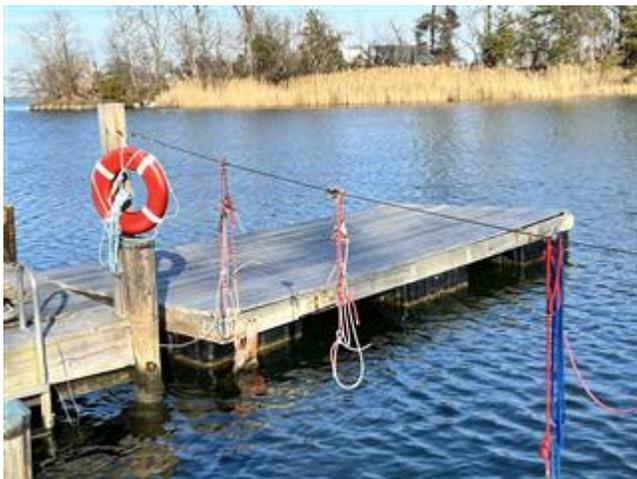
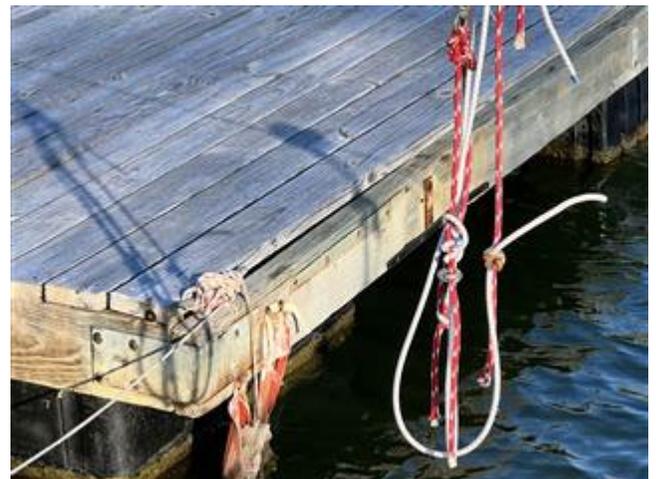
Floating Platform. The Association maintains approximately 240 square feet of a floating dock. The floating platform appears to be in good condition. Floating platforms have a useful life of around 20 to 30 years.

- **Floating Platform Decking.** The floating platform is surfaced with pressure-treated wood decking. The decking appears to be in fair condition. When necessary to resurface the platform, we recommend considering wood-plastic composites (WPCs) are composite materials made of wood fiber/wood flour and thermoplastic(s). Manufacturers claim that wood-plastic composite is more environmentally friendly and requires less maintenance than the alternatives of solid wood treated with preservatives or solid wood of rot-resistant species. WPCs do not corrode and are highly resistant to rot, decay, and insect infestation. Composite lumber comes from the manufacturer as a

- **Floating Platform Structure.** The structure consists of a pressure-treated wood frame comprised of stringers and band board, and it appears in fair to marginal condition with cracking and warping.
- **Floats.** Floats are manufactured in a variety of materials, including high-density polyethylene (HDPE), linear low-density polyethylene (LLDPE), and others, and some are filled with expanded polystyrene (EPS) foam.

finished product. There is no need to stain, sand, or paint the material. Wood-plastic composite materials usually cost more than standard lumber, but their long life and low-maintenance requirements could make them more economical in the long run.

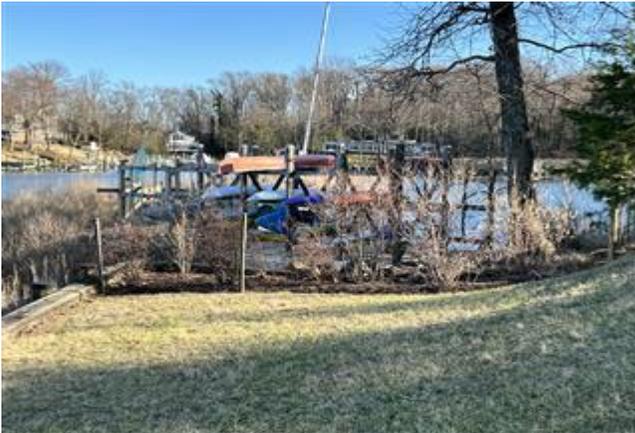
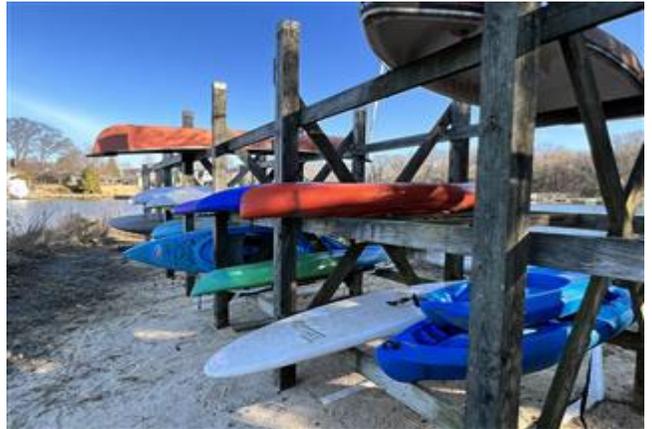
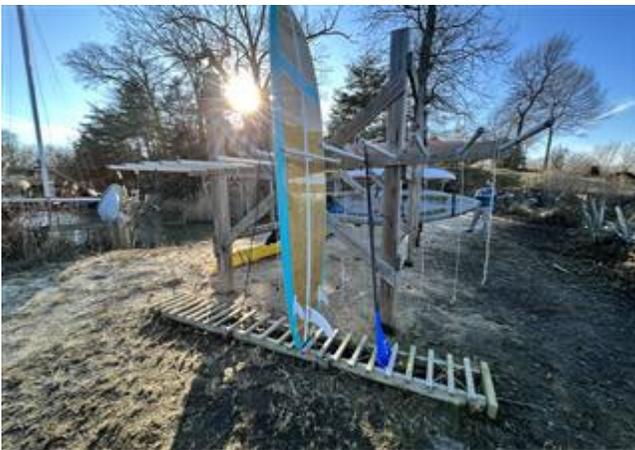
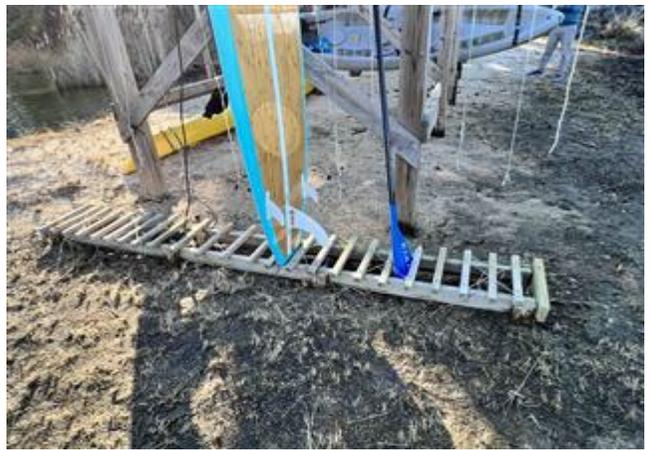
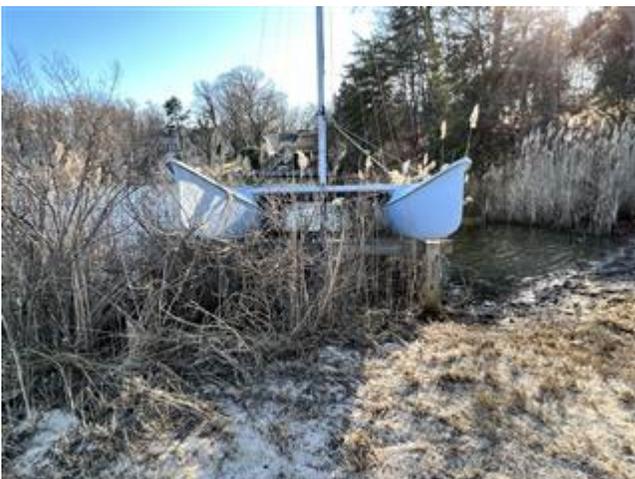
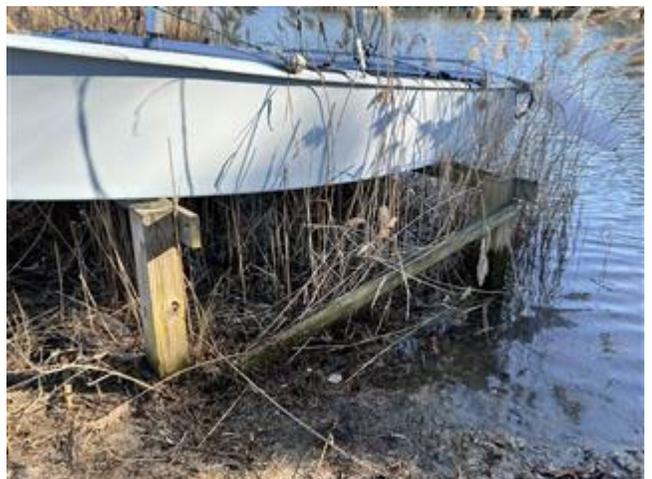
Kayak, Paddleboard, and Catamaran Storage. The Association maintains 42 Kayak storage racks and one each catamaran and paddleboard storage rack constructed of pressure-treated wood for storage purposes. The racks are stick-built and in good to fair condition with no noted defects or carpet padding. The paddleboard rack is new and appears in excellent condition. We have assumed that the components of the racks will be replaced with ones of similar type and size.

Wooden kayak racks require the same care and maintenance as any other exposed pressure-treated wood construction. Inspect the rack often: Weather and UV rays can slowly deteriorate a kayak rack's wood surface. Inspect the rack for cracks and wear. We recommend pressure washing and sealing pressure-treated wood every two years. Replace broken or deteriorated structural members as required.

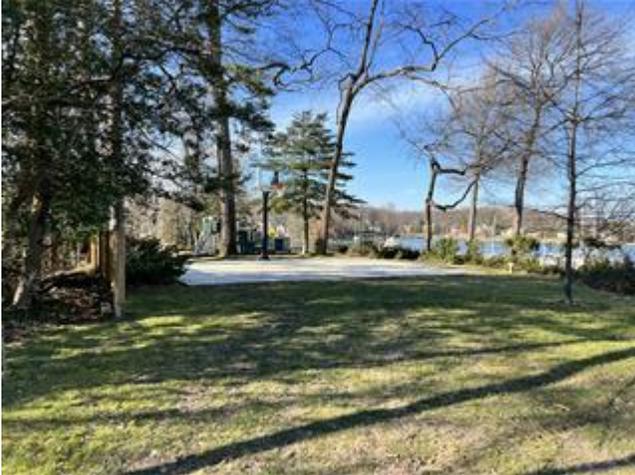
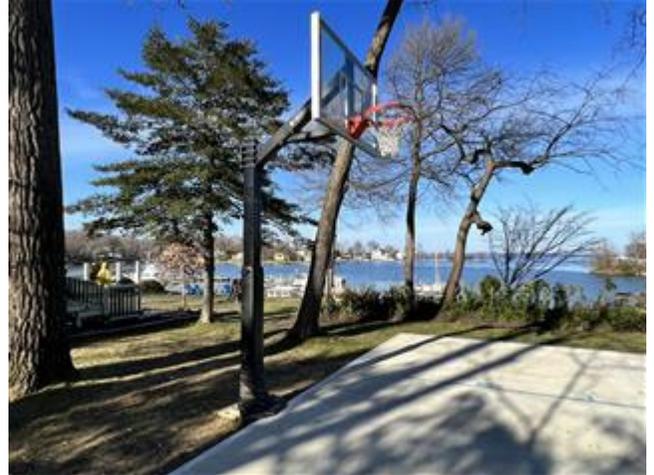
Basketball Court. The community maintains a half basketball court in the Marina area. The court surface is funded in the study as a concrete flatwork. The overall condition of the court appears to be excellent, with no noted defects.

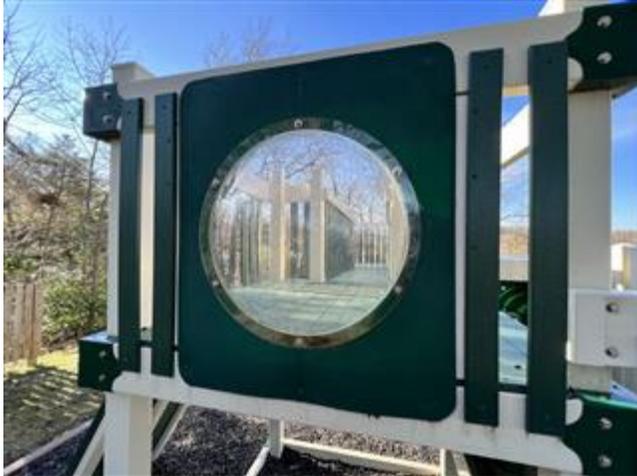
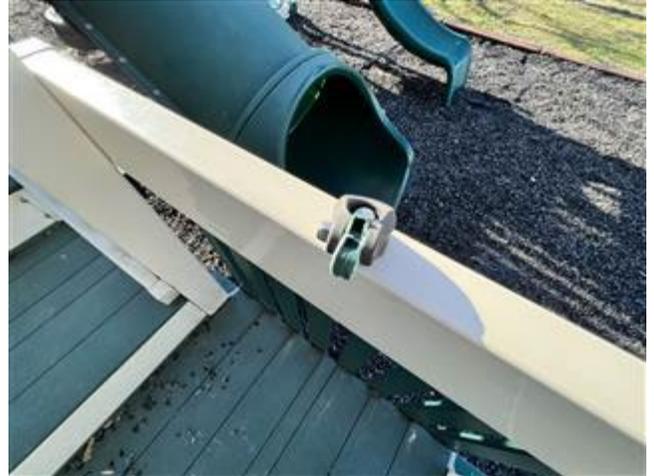
Tot Lots. The community maintains one tot lot located in the Marina area. The tot lot includes play structures, miscellaneous play equipment, synthetic borders, and a rubber chip surface. The facility facilities appear in good condition with minor wear and no noted loose connections. We noted cutting, entanglement, falling, or tripping hazards. The plastic border appears to be in good condition. The rubber chip surface is displaced or missing or does not appear to be adequate. We recommend a swing wear mat be installed under the tire swing.

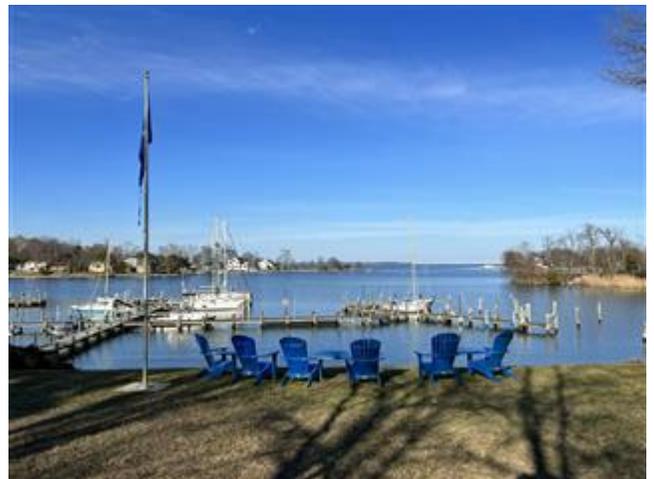
Flag Poles. The Association maintains one 20-foot aluminum flag pole with brass ornaments. The pole appears to be in good condition. The pole is of the external truck type with a cleat. Flag pole maintenance requires routine inspection and cleaning if necessary (rarely), occasional halyard, truck, and flag spring clip repair or replacement. The pole bases appear to be stable, and no leaning was observed.

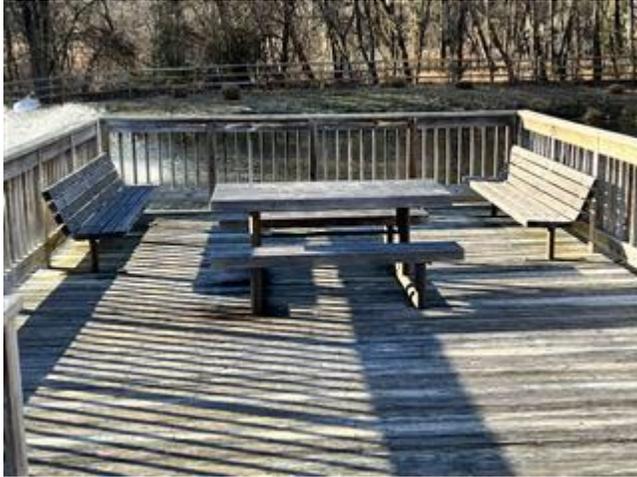
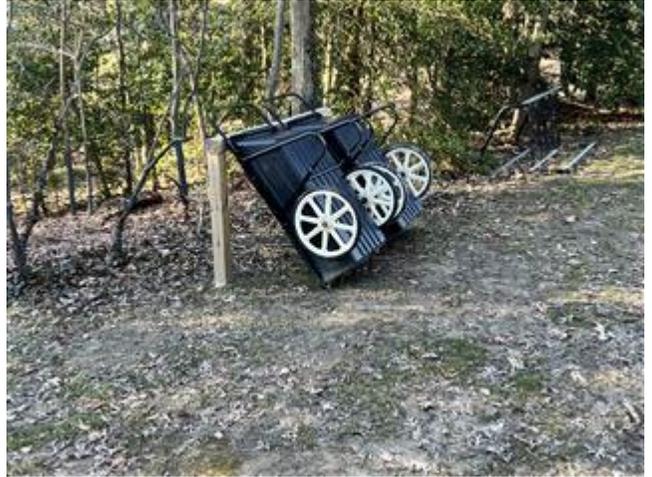
Recreation Items. The community maintains nine wooden picnic tables (one with metal supports), eight wooden benches (two with metal supports), six Adirondack chairs with end tables, one metal bike rack, and no observed trash receptacles or grills. The picnic tables appear to be in mixed condition. The benches with metal supports are in fair condition, with some noted corrosion on the supports. The Marina area benches are stick-built out of pressure-treated wood and are new and in excellent condition.

termites, and rotting. When it comes time to replace the outdoor furniture, the Community may wish to consider recycled plastic. Maintenance: Recycled plastic is easy to clean. It is smooth, does not hold water to its surface, and dries quickly.
