LEVEL 1 REPLACEMENT RESERVE REPORT FY 2023

ANNAPOLIS COVE MARINA

January 18, 2023

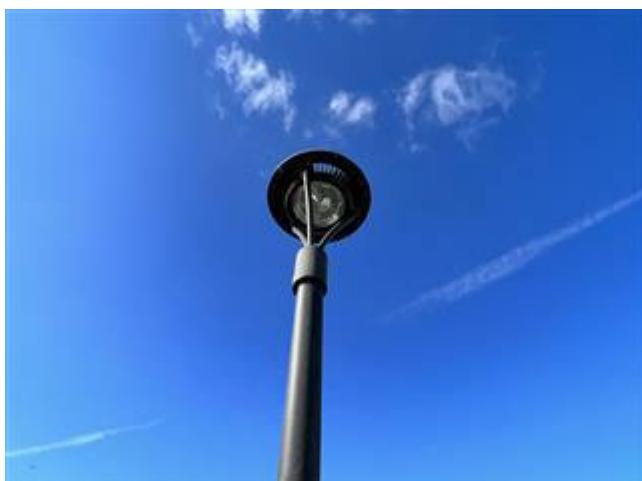
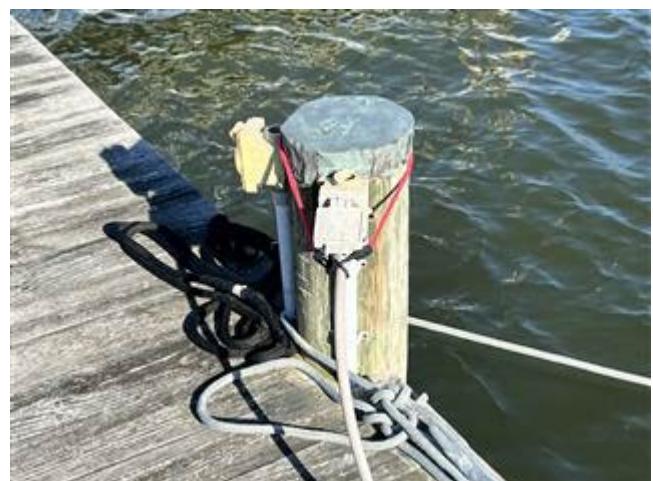
Pier Utility Systems. The pier includes lighting, electrical outlets, water supply, and fire suppression standpipe utility systems. We have assumed that the utility systems will be removed and replaced when the pier structure is replaced. We have also assumed that the systems will be replaced at the midpoint of the service life of the pier structure.

The pier utility systems appear to be in mixed fair to poor condition with rusted electrical panels, pitted light poles, broken or missing hose bibs, and broken or poorly supported water piping. The fire standpipe and electrical outlets appear to be in fair condition

It is recommended that all piers be inspected at least once each year to identify damage to pilings, structural members, surface boards, and railings.

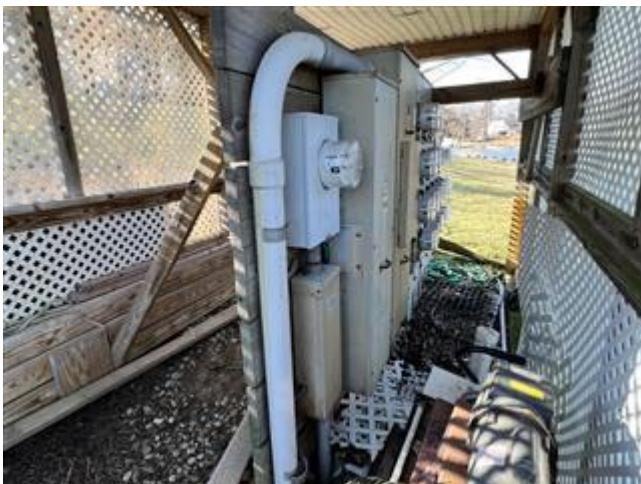
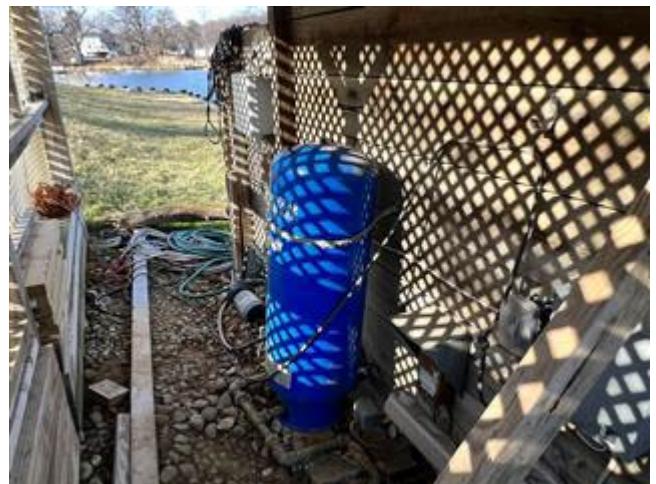
Electrical Service. The electrical systems of the marina are reported to be operating normally.

Other than transformers and meters and if protected from water damage or overloading, electrical systems within a shed, including feed lines and switchgear, are considered long-life components. Unless otherwise noted, they are excluded from this study.

To maintain this equipment properly, periodic tightening of all connections is recommended every three to five years. Insurance policies in some cases may have specific requirements regarding the tightening of electrical connections. It is also recommended that outlets, sockets, switches, and minor fixtures be replaced at a maximum of every 30 years.
